City of Highland Park
Historic Preservation Commission
Thursday, October 13, 2016
1707 St. Johns Avenue, City Hall
7:30 p.m.

REGULAR MEETING AGENDA

To: Andy Cross, Senior Planner
From: Emmanuel Gomez, City Engineer
Date: 09/16/2016
Re **Highland Park Historic Preservation Commission
Central Ave Bridge Replacement**

DRAFT
SECTION 106 / SECTION 4(f)
DOCUMENTATION OF ADVERSE EFFECT

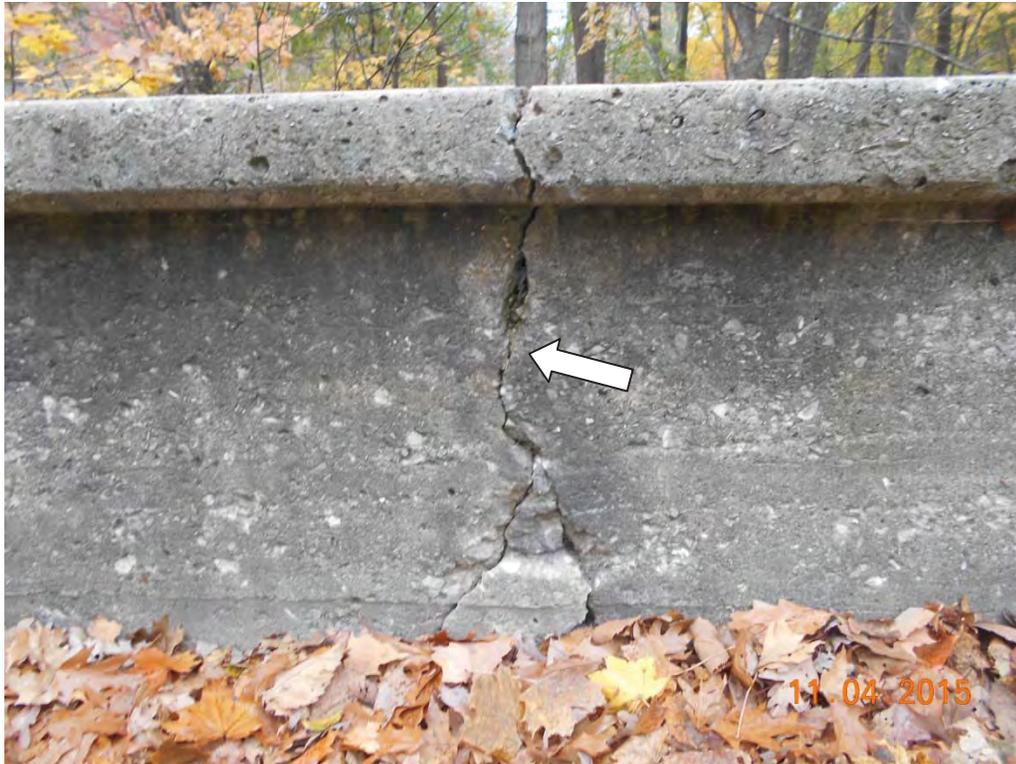
The bridge is in poor structural condition. The concrete parapet rails are cracked vertically at 18 locations and are leaning out towards the ravine. The parapet wall base is spalled and its reinforcing bars are exposed causing decaying corrosion. In 2014 the City of Highland Park mobilized a contractor to perform emergency repairs at the northeast quadrant of the bridge to install a concrete encased steel soldier pile system so as to prevent wall from falling into the ravine.

Photo 3: Severe cracking at the north parapet.

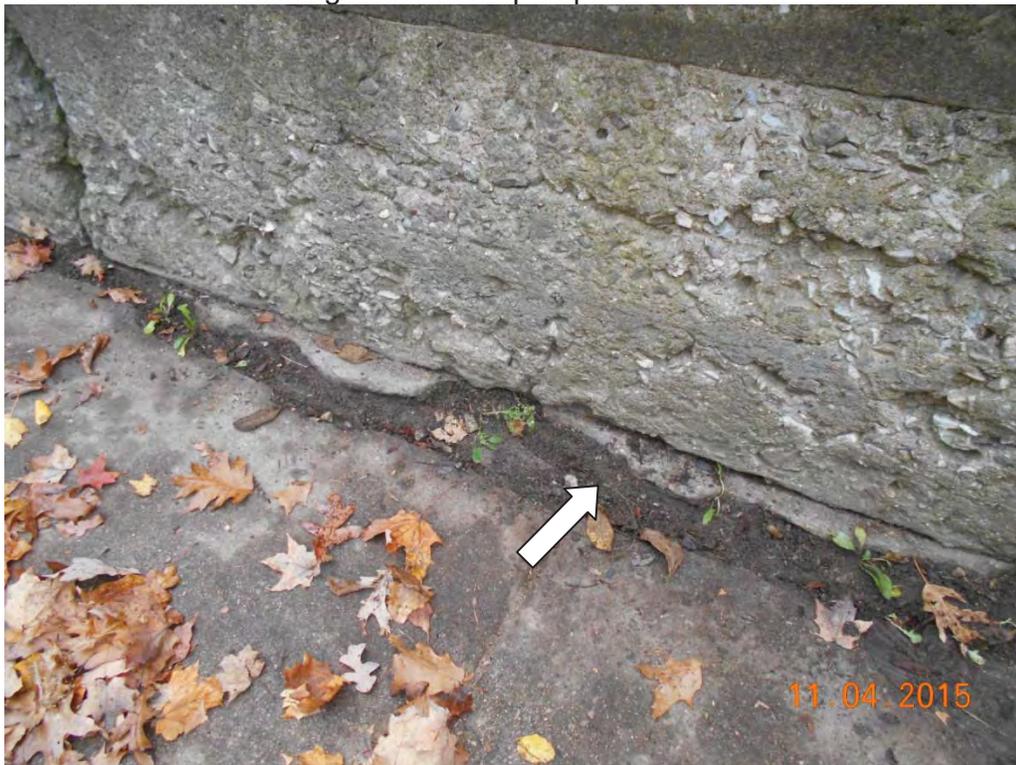
³ ⁶ In addition, the south parapet is leaning away from the roadway, indicating that the spandrel wall is leaning away from the bridge centerline. If nothing is done, it could eventually spall off and fall which would endanger the public safety.

Photo 4: Separation between the south parapet and the sidewalk.

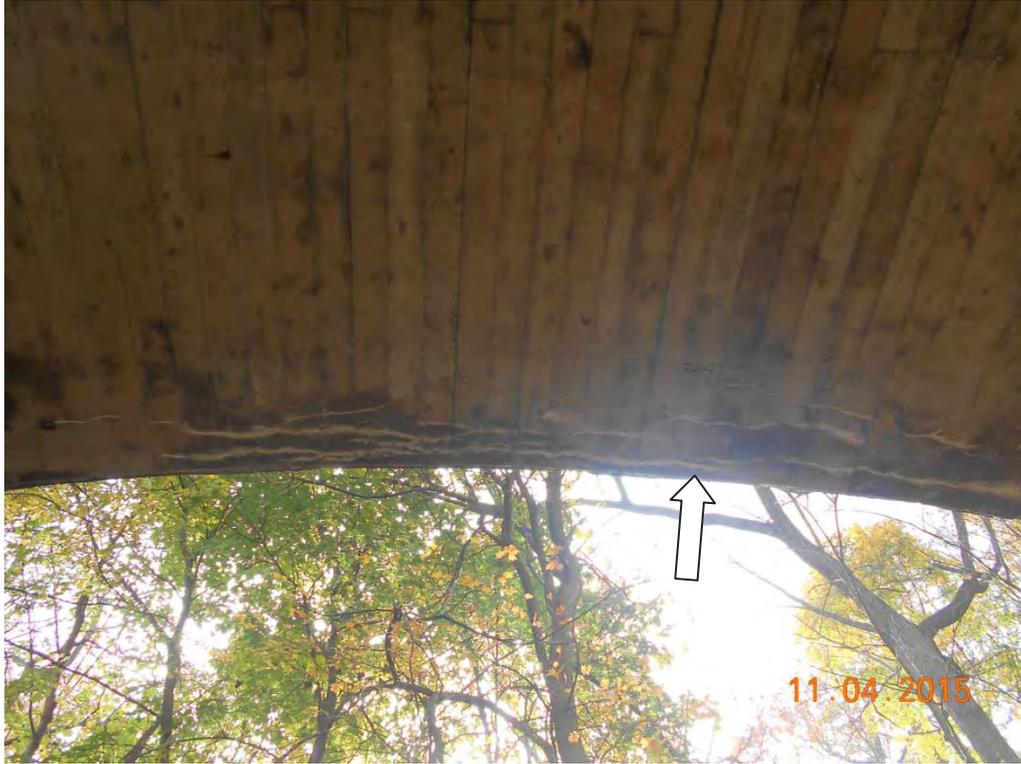
south end of the underside of the arch ring indicate that the wearing surface has failed and water is penetrating through the fill and into the concrete. The fill would likely need to be replaced to reduce the deterioration which is ¹not cost effective.

Photo 7: Efflorescence at the underside of arch at the south end.

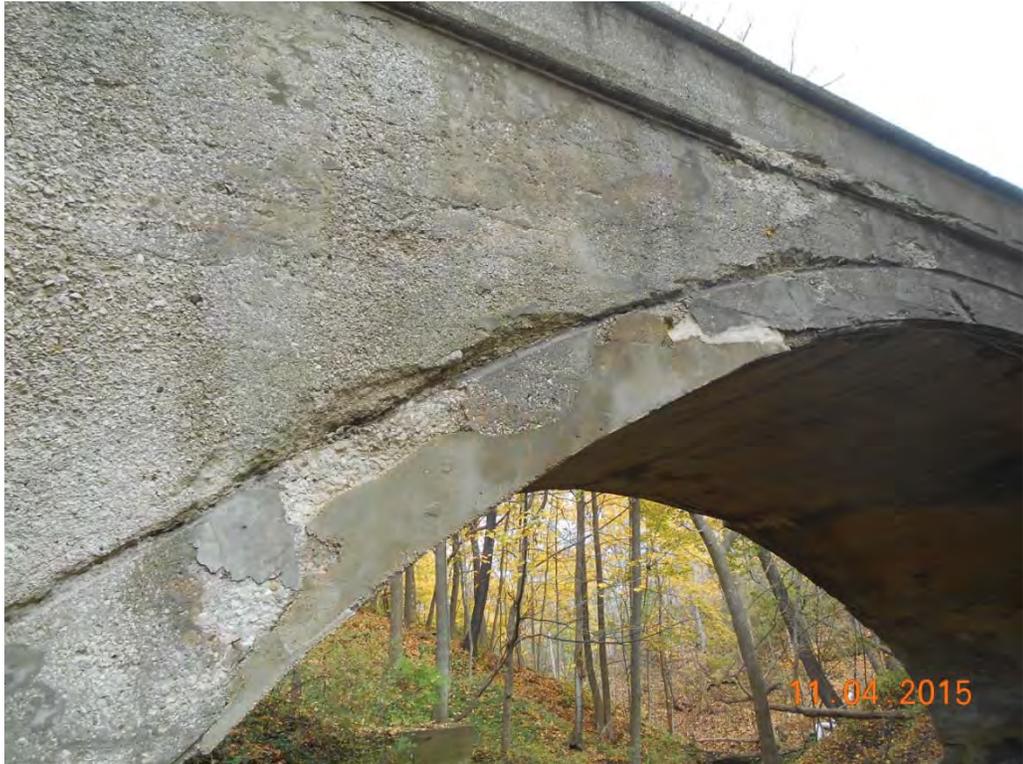
Photo 8: Spalling at the south elevation spandrel wall.

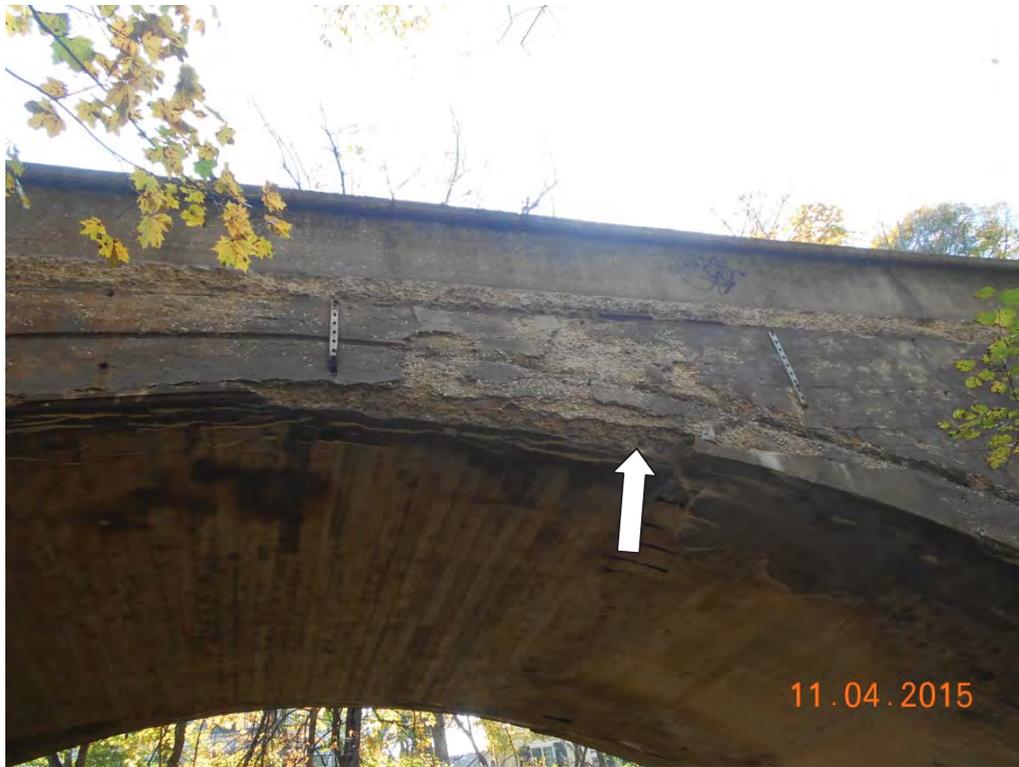
Photo 9: Spalling at the north elevation.

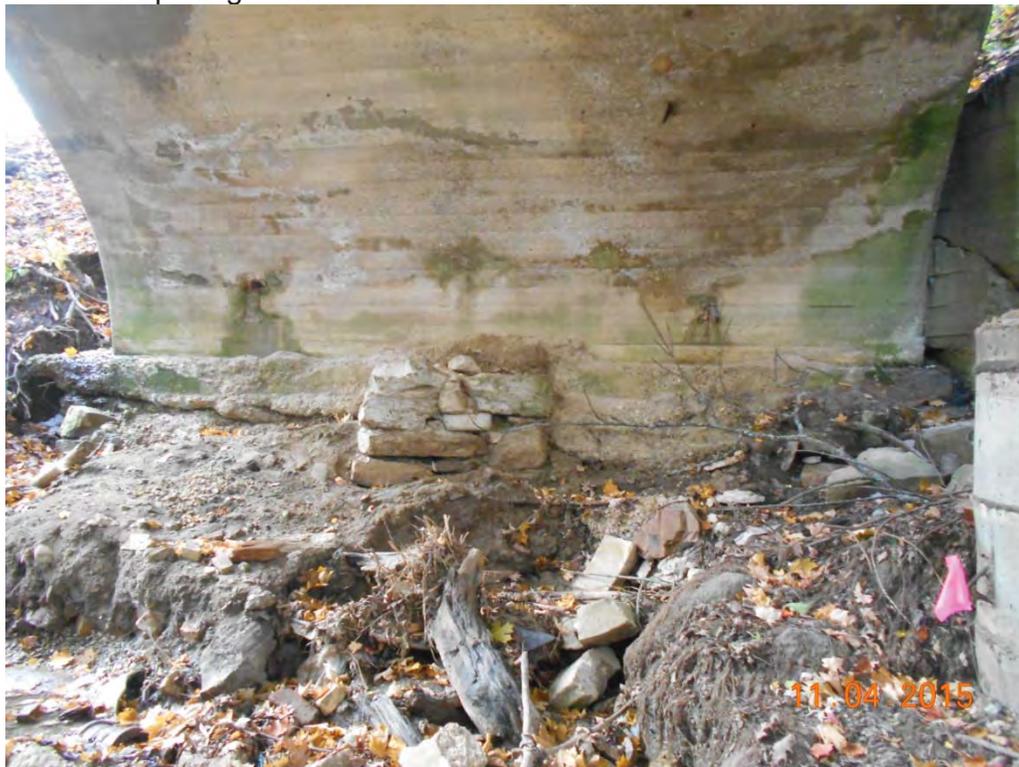
Photo 10: Scour at the west foundation.

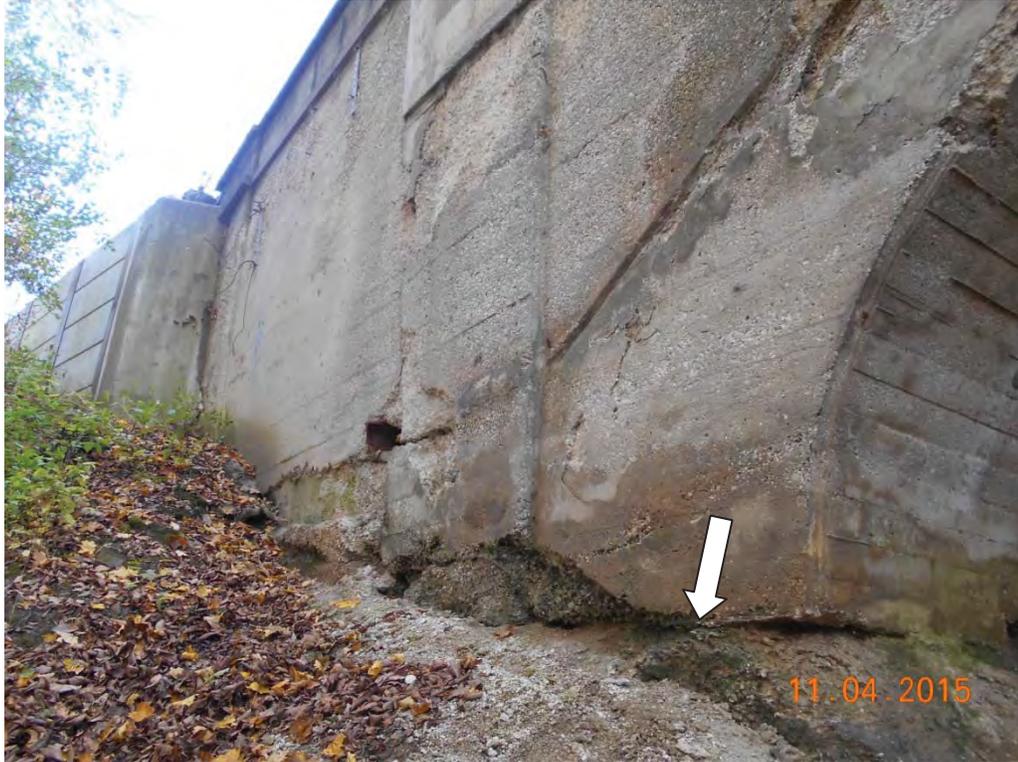
Photo 11: Deterioration at the northeast wingwall and footing interface.

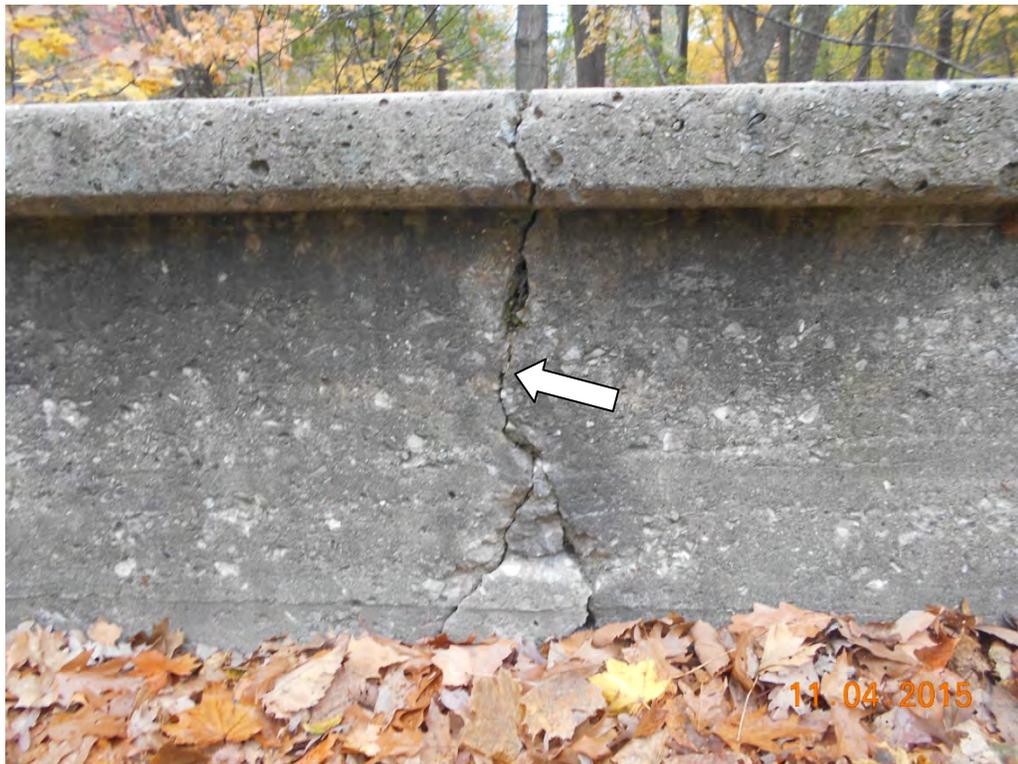
Photo 3: Severe cracking at the north parapet.

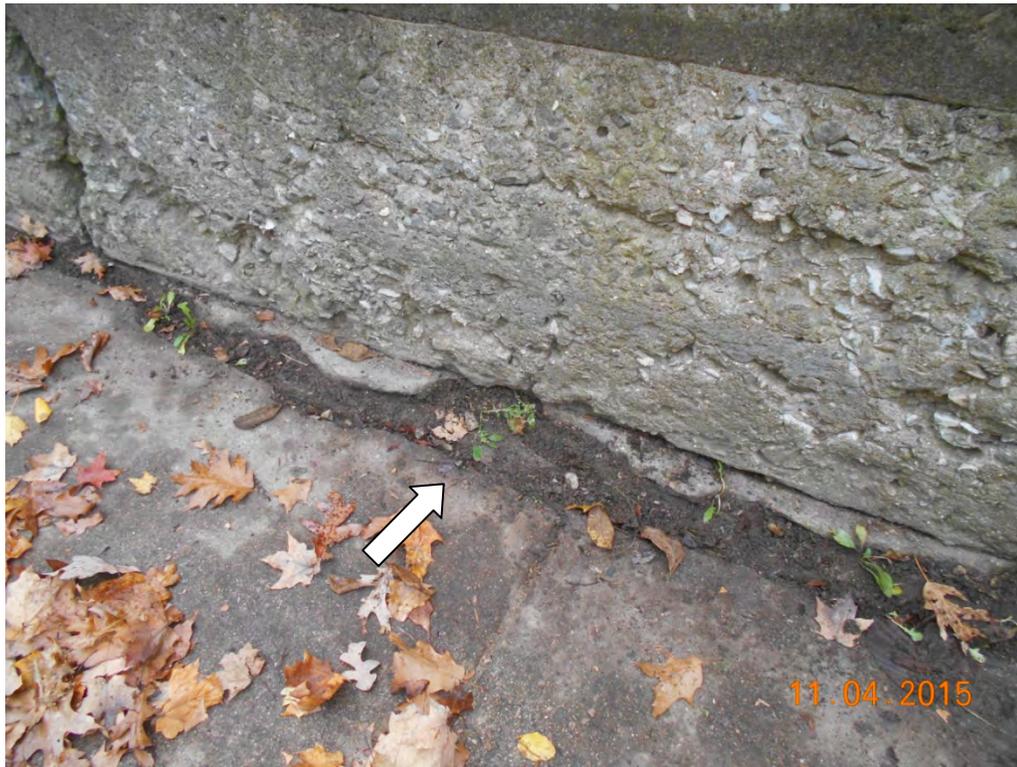
Photo 4: Separation between the south parapet and the sidewalk.

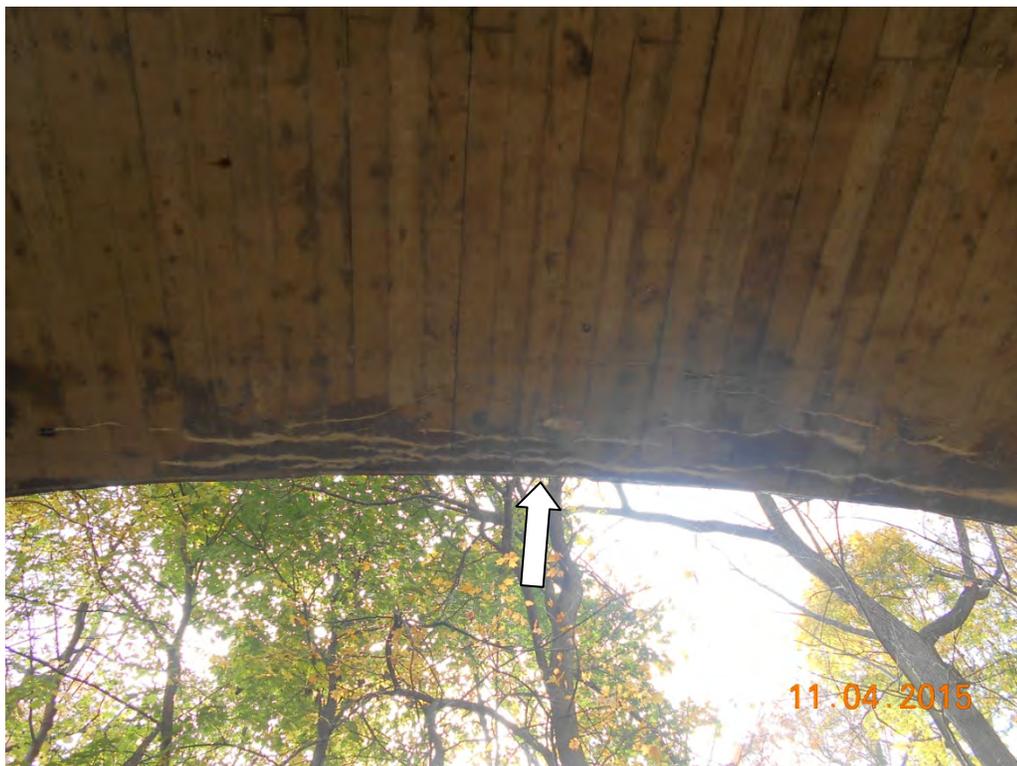
Photo 7: Efflorescence at the underside of arch at the south end.

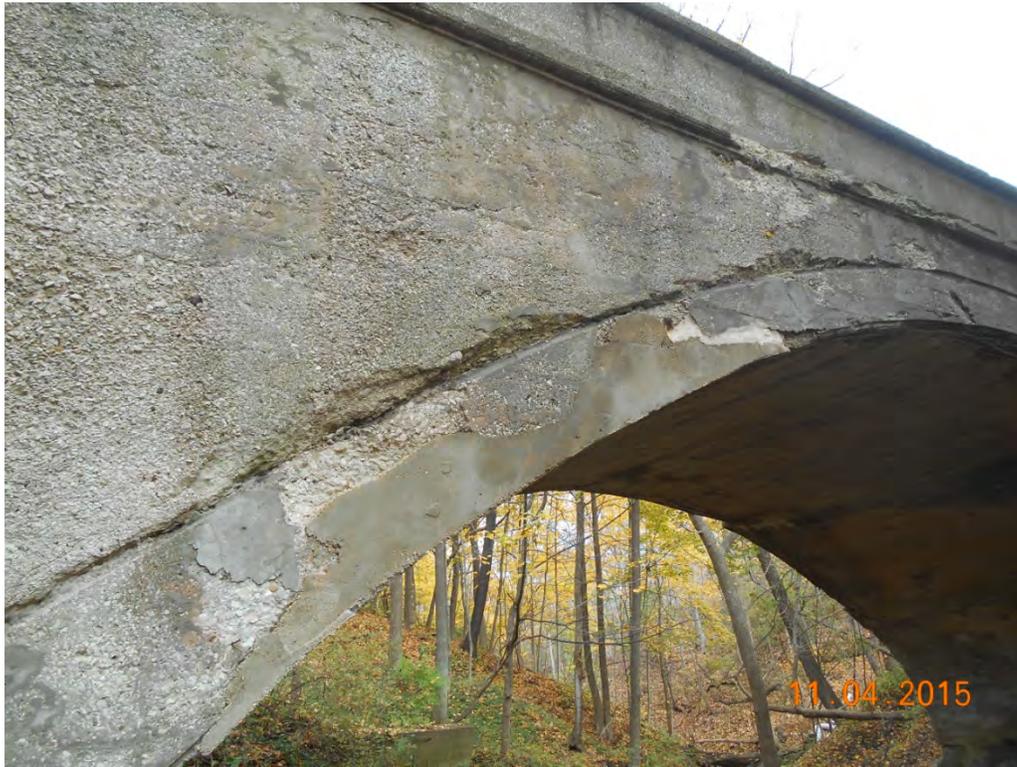
Photo 8: Spalling at the south elevation spandrel wall.

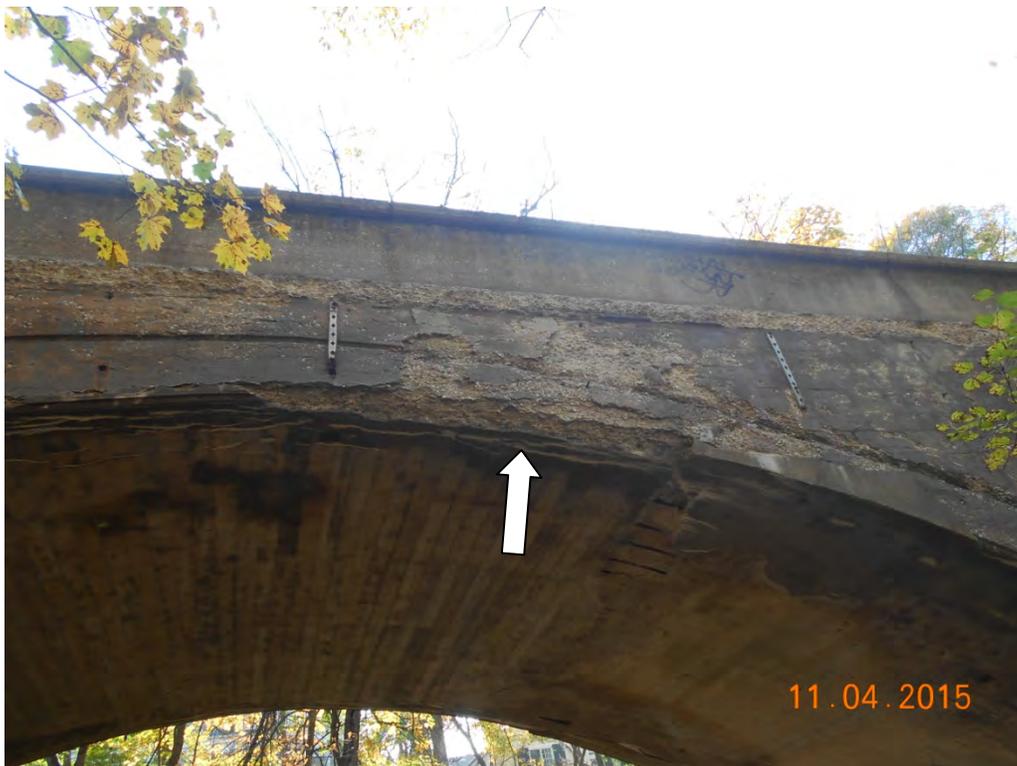
Photo 9: Spalling at the north elevation.

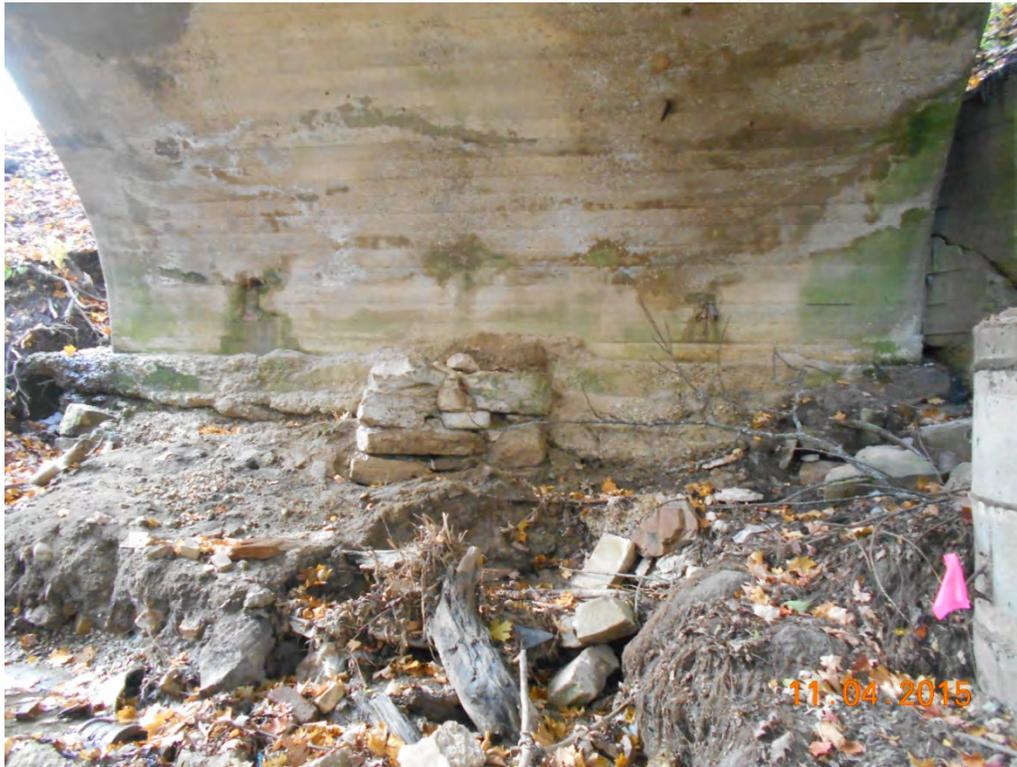
Photo 10: Scour at the west foundation.

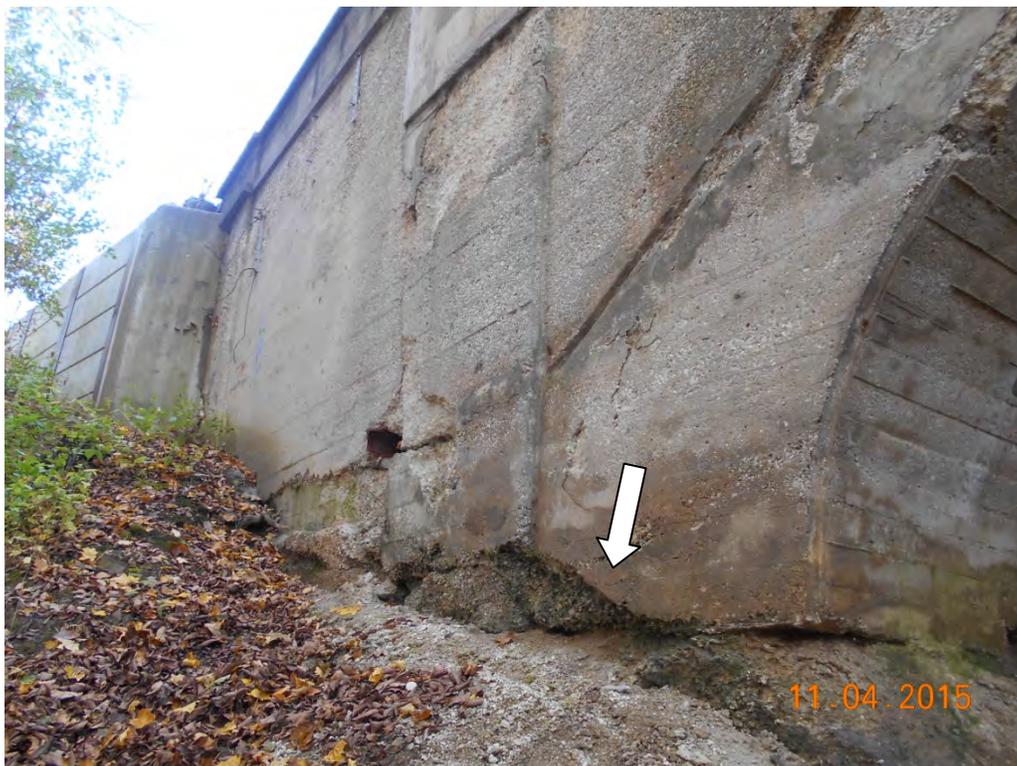
Photo 11: Deterioration at the northeast wingwall and footing interface.

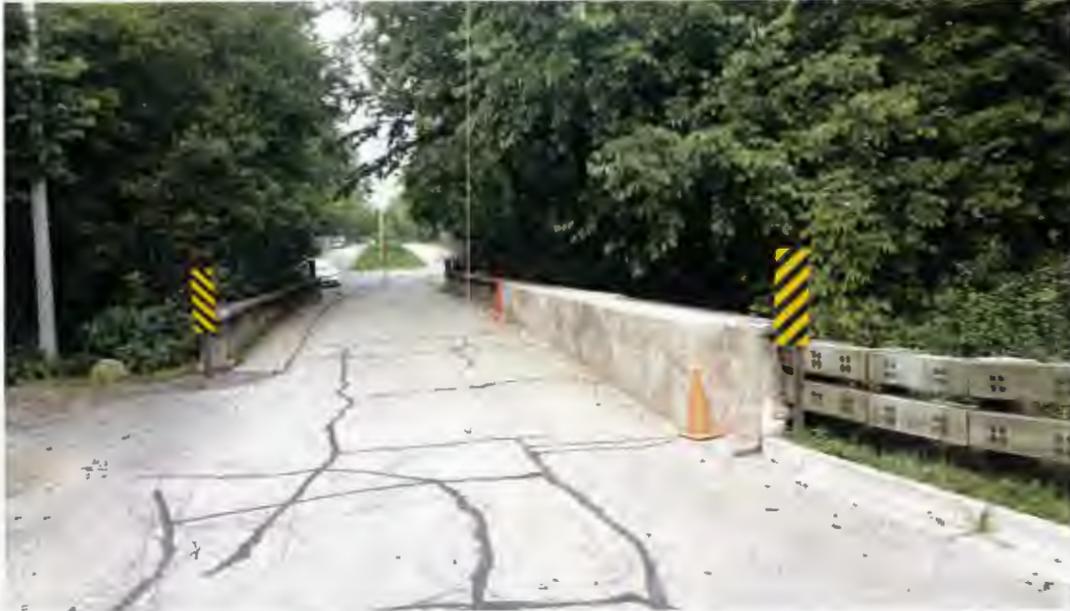
Image Ctrl 01a - Central Av Bridge East Approach with emergency retrofit northeast wall, Sept. 2014

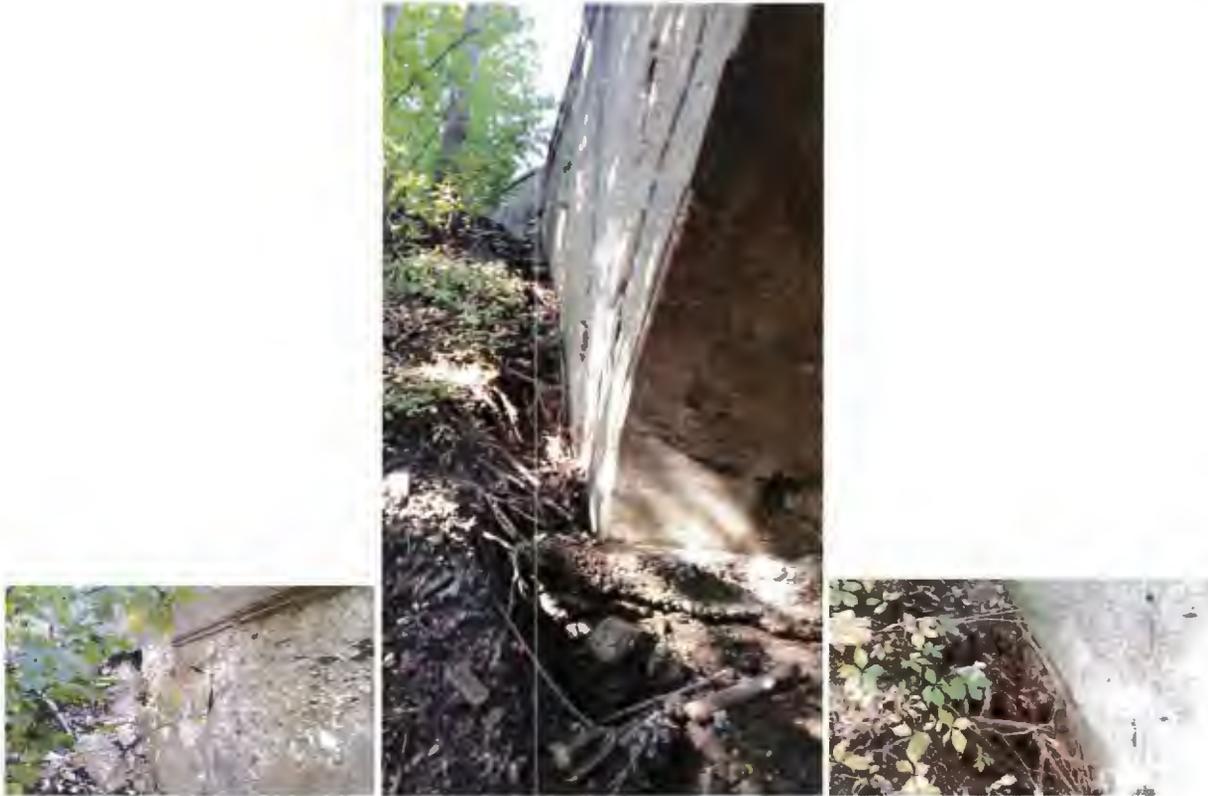
Photo Ctrl 07 – Central Av Bridge, Southwest Spandrel Wall/Foundations Scouring, 08/19/2014

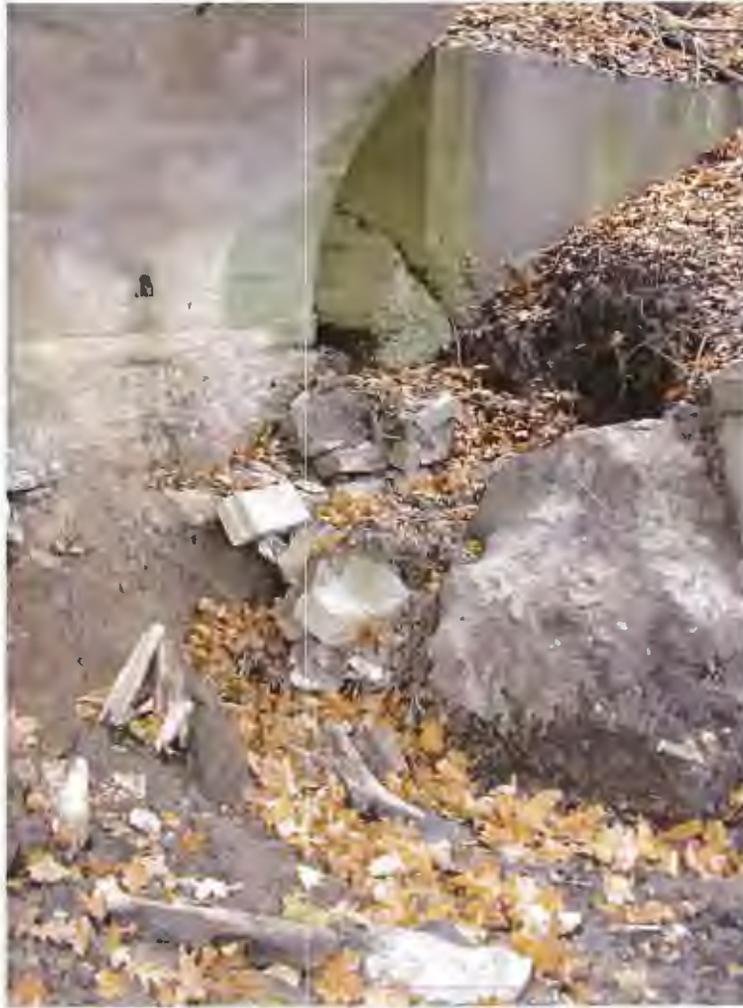
Photo Ctrl 13a – Central Av Bridge, Northwest Foundations Scouring

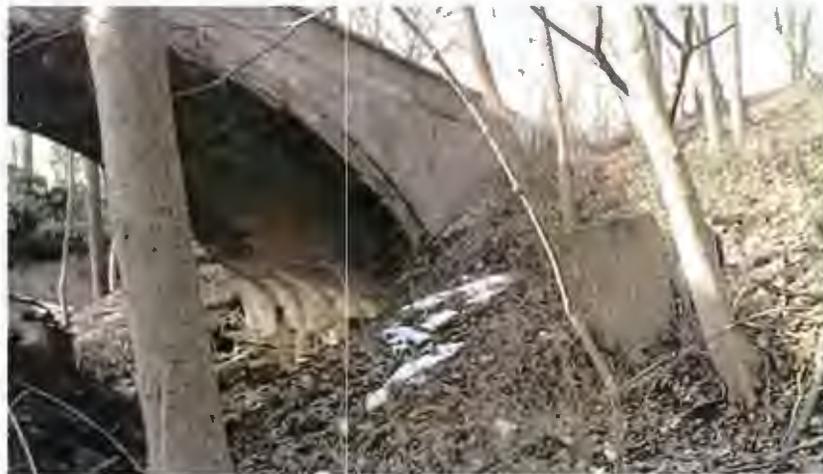
Photo Ctrl 13b – Central Av Bridge, Northwest Rotating Embankment Wall
