## PUBLIC NOTICE

City of Highland Park  
Historic Preservation Commission  
**Thursday, June 12, 2014**  
1707 St. Johns Avenue, City Hall  
**7:30 p.m.**

### **REGULAR MEETING AGENDA**

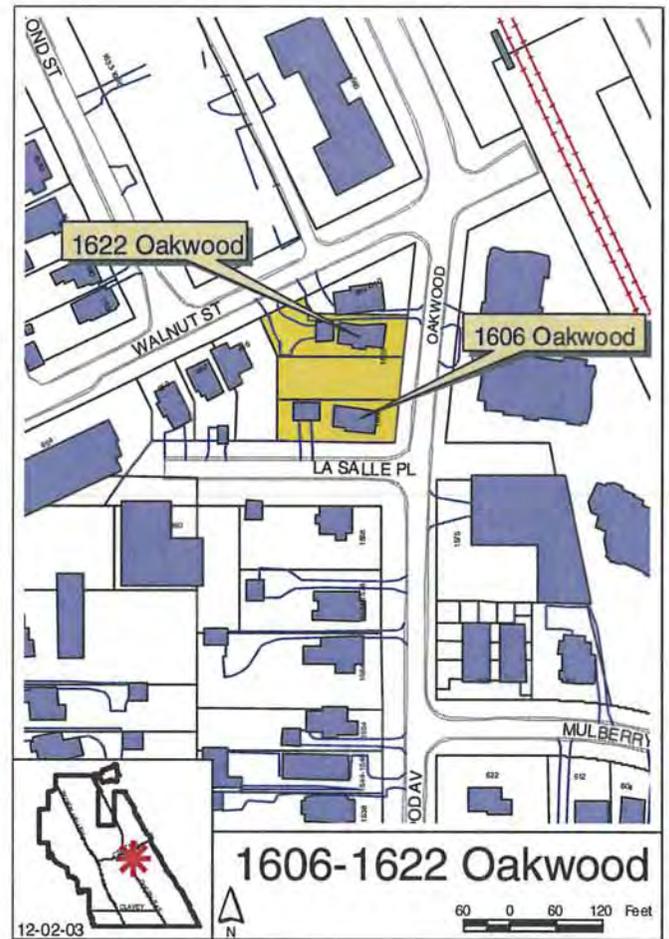
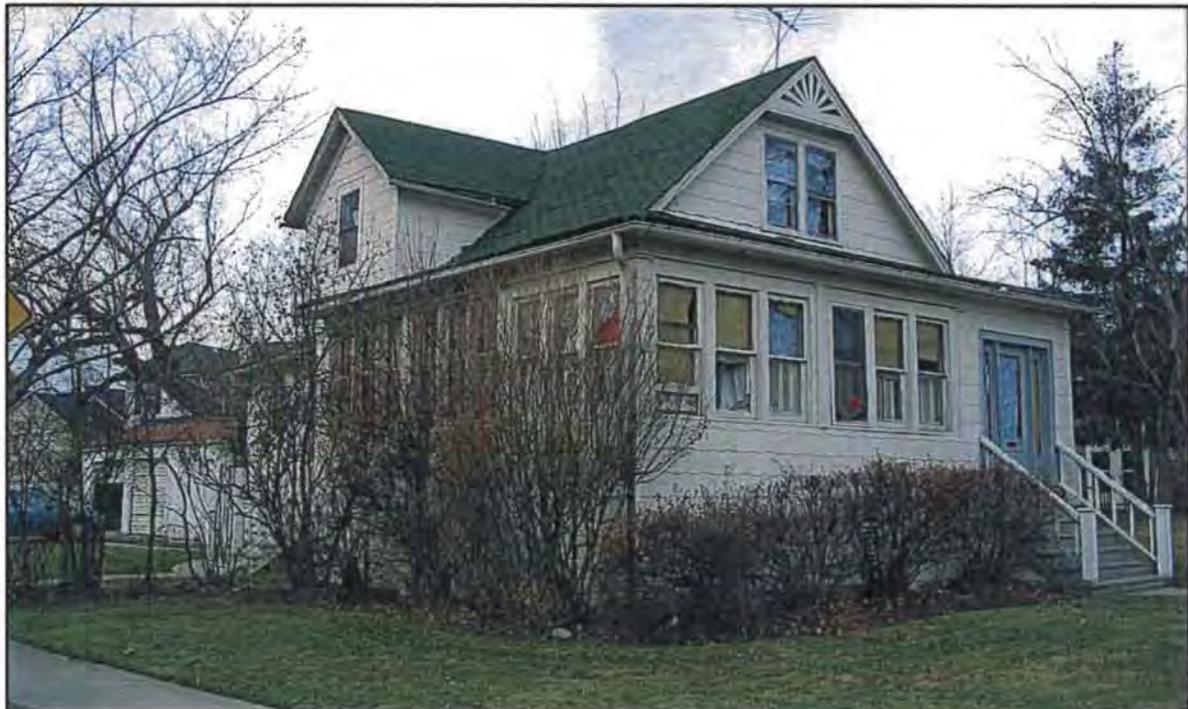
This home is in poor condition as seen from the public right of way. It does not appear to fulfill landmark criteria at this time.

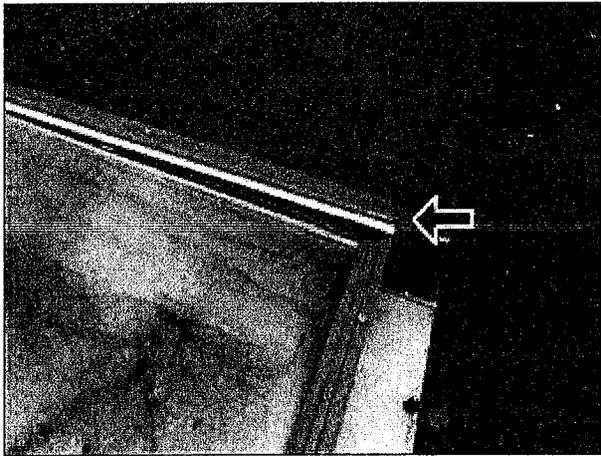
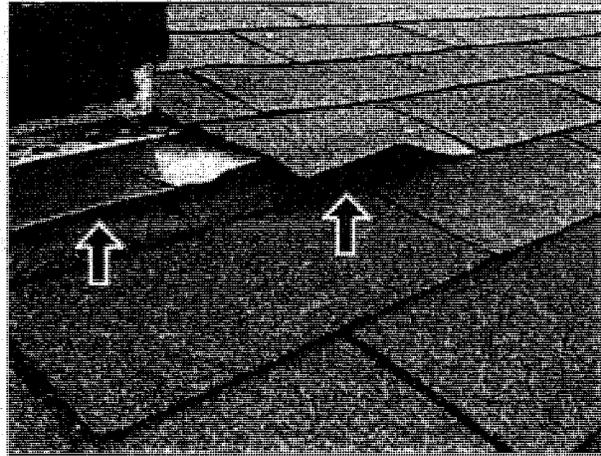
**1.2** Two Skylights have flashing that is loose and pulling away from the roof at the Kitchen and Hall Bath. Repairs are needed. A qualified contractor should repair or replace as needed.

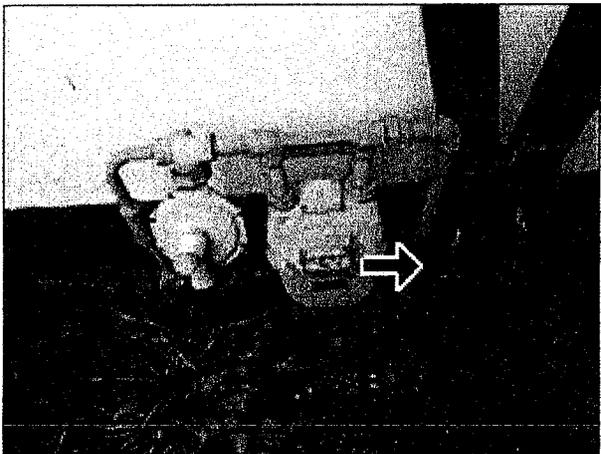
**1.3 (1)** The downspouts at the front, rear and sides of the home need to be extended further away from the home. This is allowing water to enter the basement and crawlspaces and is causing damage. We recommend that a qualified contractor review and repair as needed.

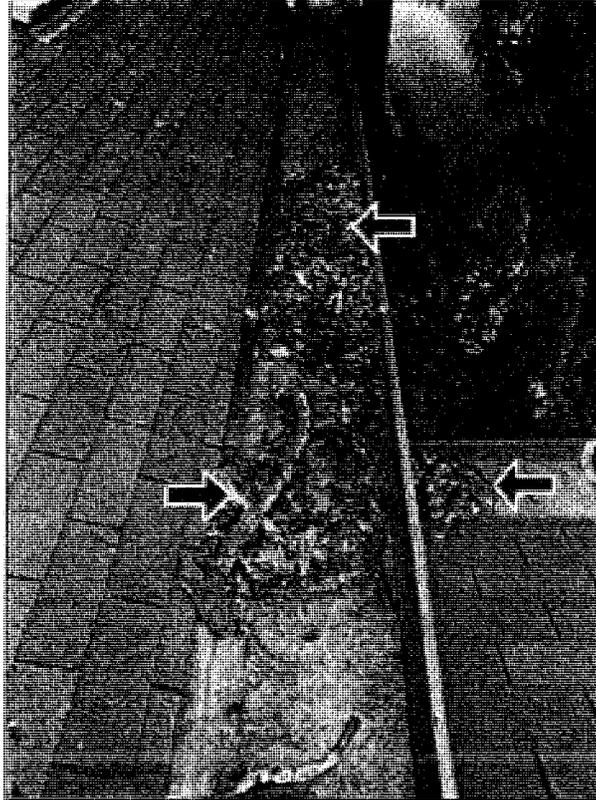
1.3 Picture 3

(2) The gutters are full of debris in areas and needs to be cleaned. The debris in gutters can also conceal rust, deterioration or leaks that are not visible until cleaned, and I am unable to determine if such conditions exist. We recommend that a qualified contractor review and repair as needed.

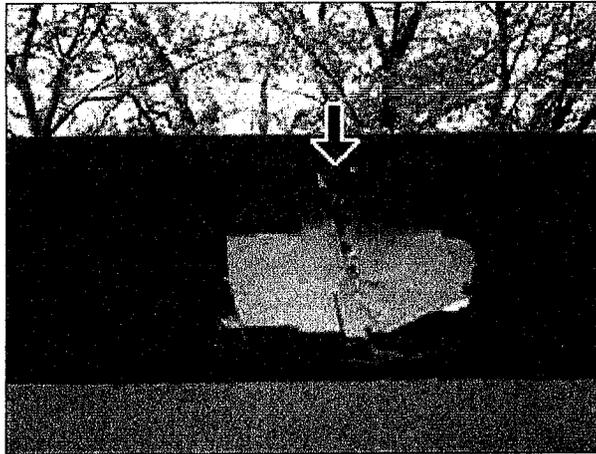
2.5 Picture 1

**2.5** The fascia on the east side of the home is deteriorated.Further deterioration can occur if not repaired.We recommend that a qualified contractor review and repair as needed.

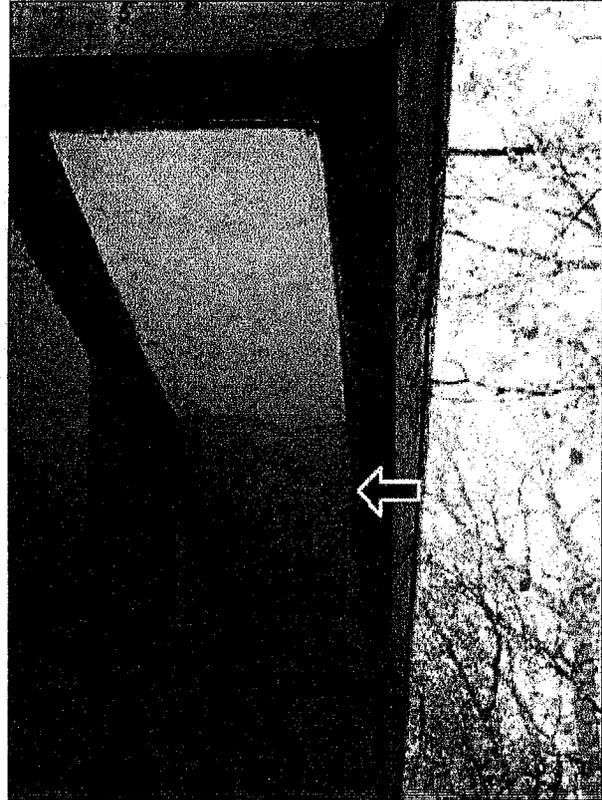
(2) The stucco soffits on the garage have come loose. Repairs are needed. We recommend that a qualified contractor review and repair as needed.

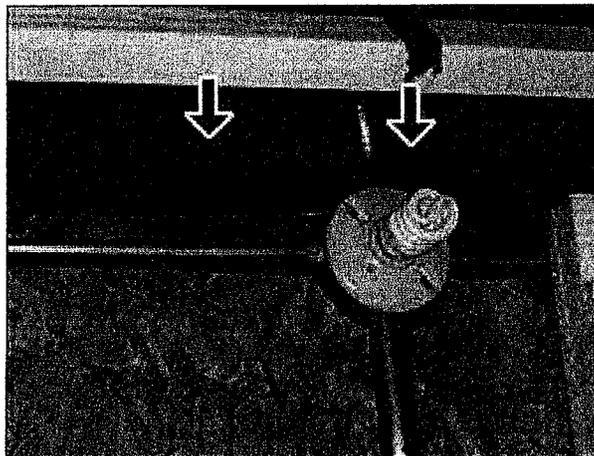
3.1 Picture 1

3.1 (1) Signs of fungi growth are present on the roof plywood in several areas in the garage. We did not inspect, test or determine if this growth is or is not a health hazard. The underlying cause is moisture or dampness. I recommend you contact a mold inspector or expert for investigation or correction if needed.

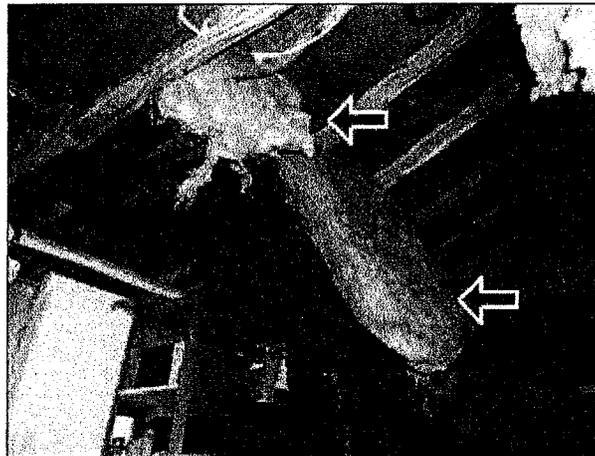
3.1 Picture 2

(2) The insulation on the ceiling in the garage is falling down. Heat lose can occur if repairs are not performed. We recommend that a qualified contractor review and repair as needed.

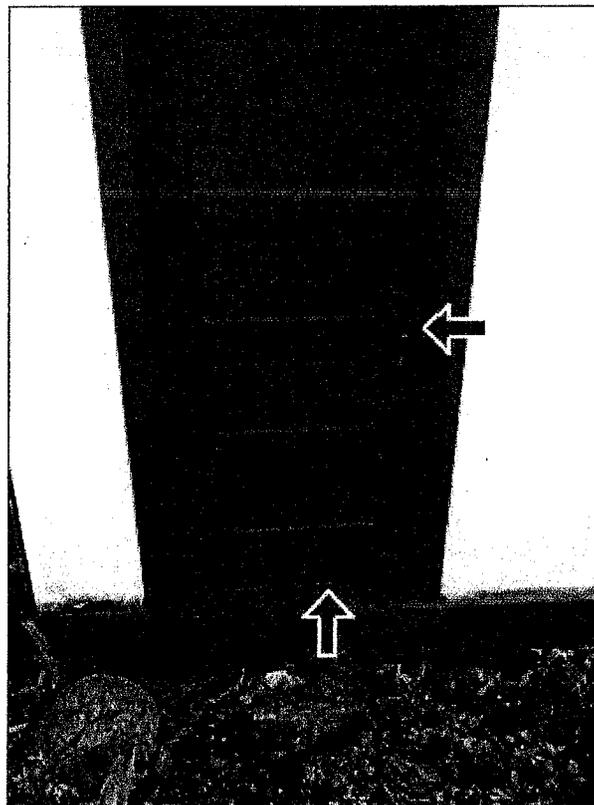
3.4 Picture 1

3.4 The side garage entry door is missing hardware and hit threshold when closed. Repairs are needed. A qualified contractor should inspect and repair as needed.

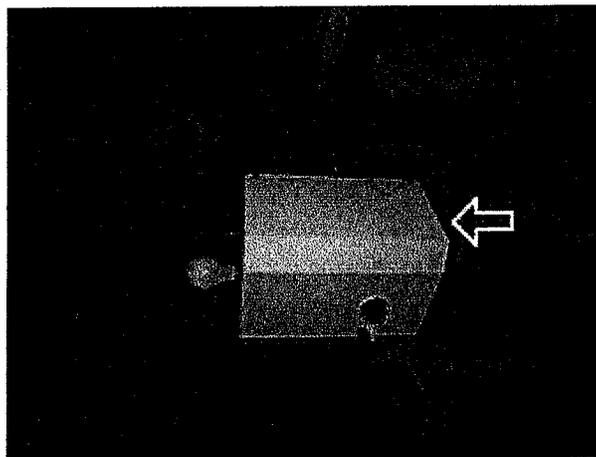
3.5 Picture 1

3.5 The automatic opener for garage door at the rear of home did not work. Repairs are needed. A qualified contractor should inspect and repair as needed.

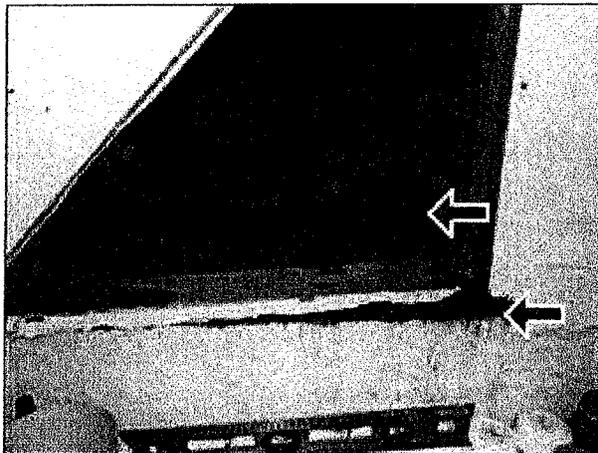
5.0 (1) Visible signs of water intrusion in the crawlspace and basement are present from standing water. Water intrusion can lead to more costly repairs and increase damage if not corrected.. I recommend further investigation or correction by a qualified licensed contractor or water infiltration specialist.

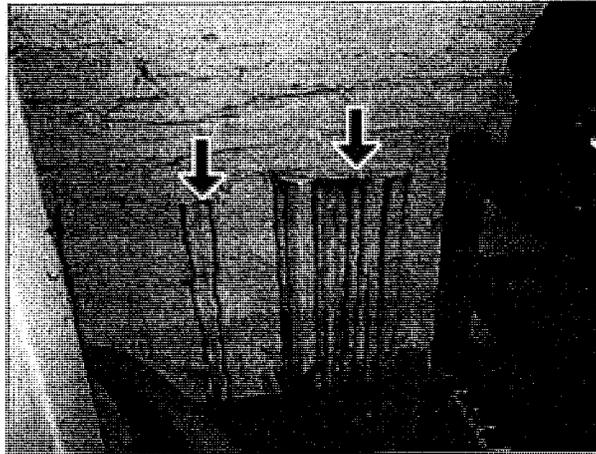
5.0 Picture 7

(2) The horizontal crack(s) in the foundation wall at the (East side of home). Repairs are needed. A qualified water infiltration contractor should inspect further and repair as needed.

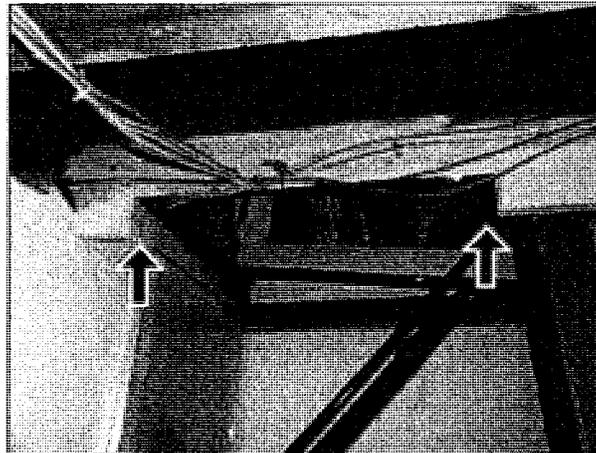
5.3 Picture 2

(2) At least One floor joist is cut or damaged by Tradesman at the opening to the basement stairs . Repairs are needed. I recommend repair or replace as needed.

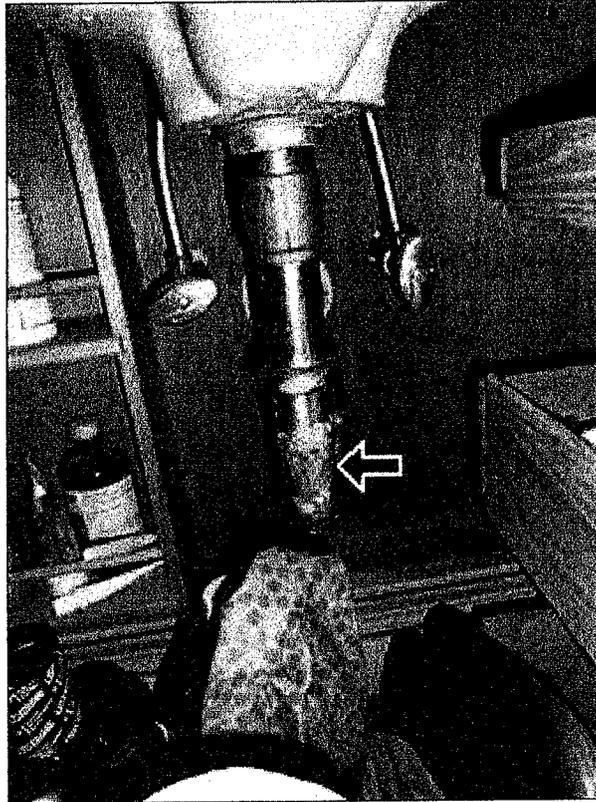
6.0 Picture 1

6.0 (1) The plumbing waste line rusted and deteriorated at P-trap under the master bath. Repairs are needed. A qualified licensed plumbing contractor should repair or correct as needed.

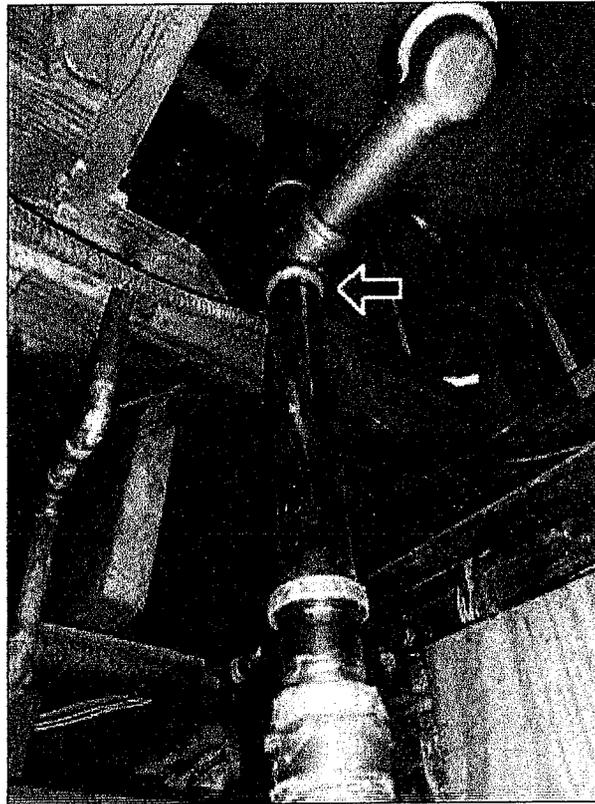
6.0 Picture 3

(3) The plumbing waste line has been repaired improperly under the hall bath tub. Repairs are needed. A qualified licensed plumbing contractor should repair or correct as needed.

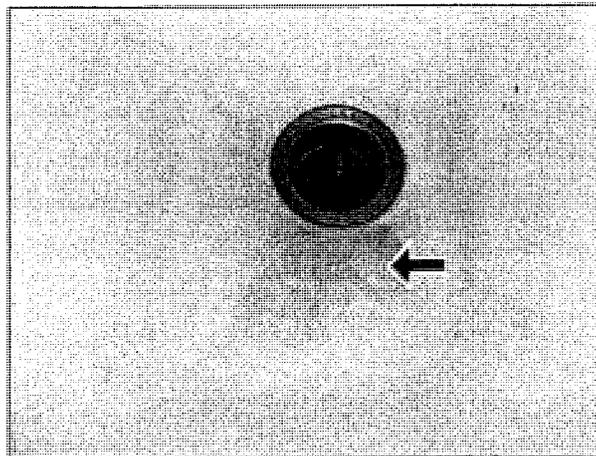
6.1 Picture 1

6.1 The sink is damaged at the kitchen. Repairs are needed A qualified licensed plumbing contractor should repair or correct as needed.

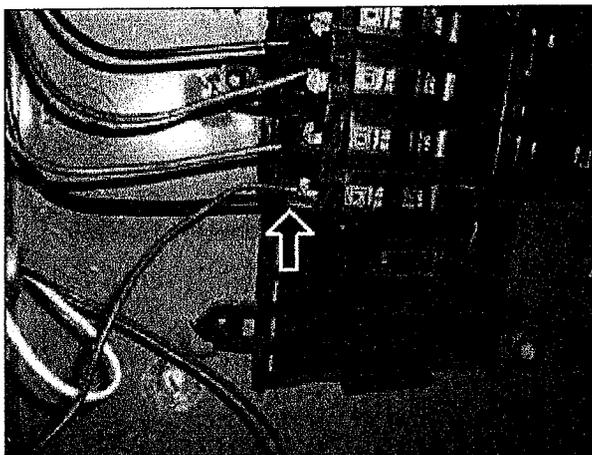
7.1 Picture 1

7.1 The problem(s) discovered in the panel such as double wiring at breaker(s) (double tap) and any other problems that an electrical contractor may discover while performing repairs need correcting. I recommend a licensed electrical contractor inspect further and correct as needed.

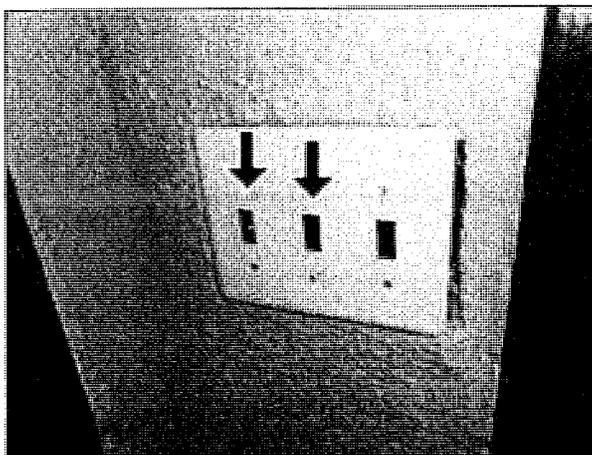
7.3 Picture 1

7.3 (1) The wall switch is loose in the wall at the main entry. This is a safety issue that needs to be corrected. A qualified licensed electrical contractor should correct as needed.

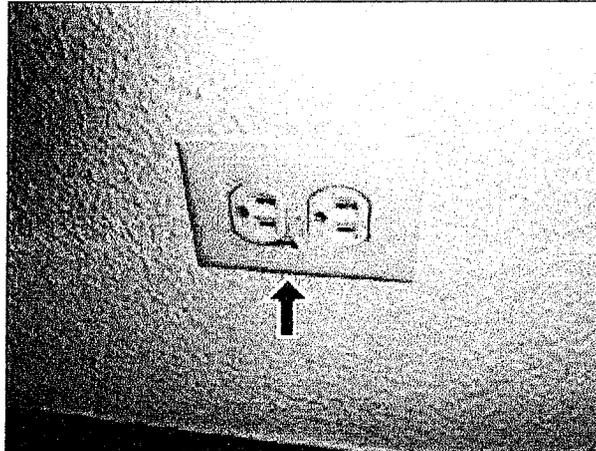
7.3 Picture 2

(2) At least one "three-prong" outlet is broken or damaged cover-plate in the living room south wall. This is a safety issue that needs to be corrected. A qualified licensed electrical contractor should correct as needed.

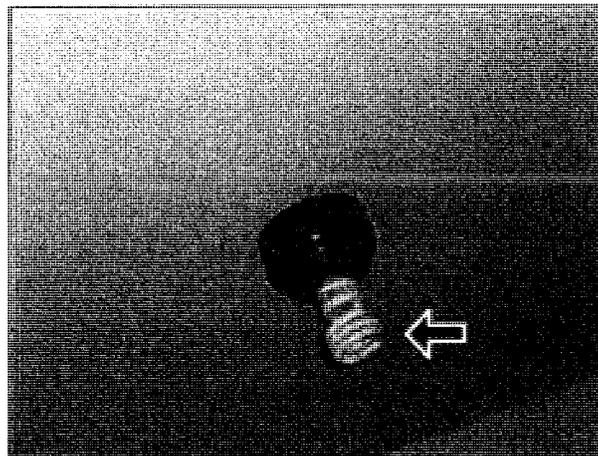
7.3 Picture 3

(3) Bare bulbs found in closets. This is a fire hazard and should be repaired. Have reviewed and repaired by a licensed electrician.

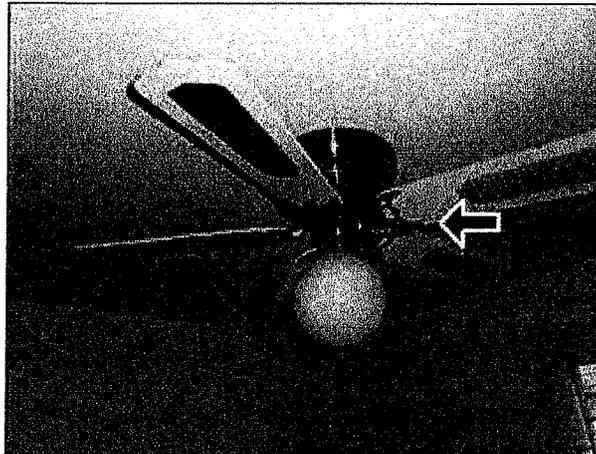
7.3 Picture 4

(4) The ceiling fan does not work properly at the Guest Bedroom. Further inspection is needed by a qualified licensed electrical contractor. A qualified licensed electrical contractor should correct as needed.

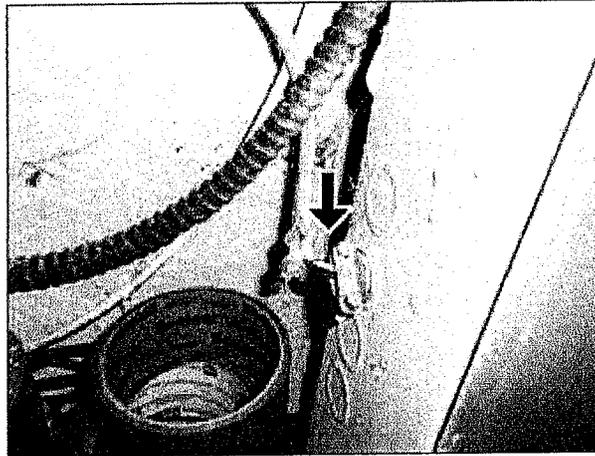
7.3 Picture 8

(6) Romex wiring was found at the electrical panel. Romex wiring is not allowed. We recommend that a licensed electrical review and repair as needed.

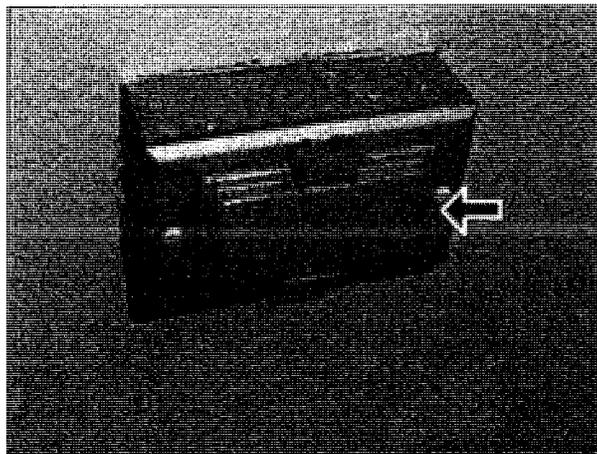
7.5 Picture 1

7.5 (1) At least One GFCI (Ground Fault Circuit Interrupter) outlet at the rear of home did not work or there is no power to outlet. This is a safety issue that needs to be corrected. A qualified licensed electrical contractor should correct as needed.

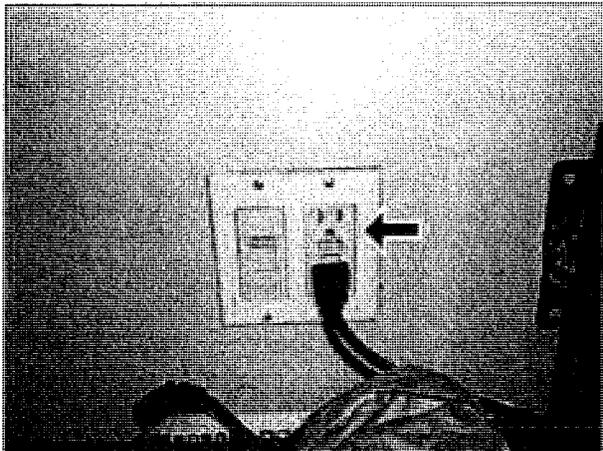
7.5 Picture 2

(2) At least Two GFCI (Ground Fault Circuit Interrupter) outlets at the Kitchen did not trip when tested (defective). This is a safety issue that needs to be corrected. A qualified licensed electrical contractor should correct as needed.

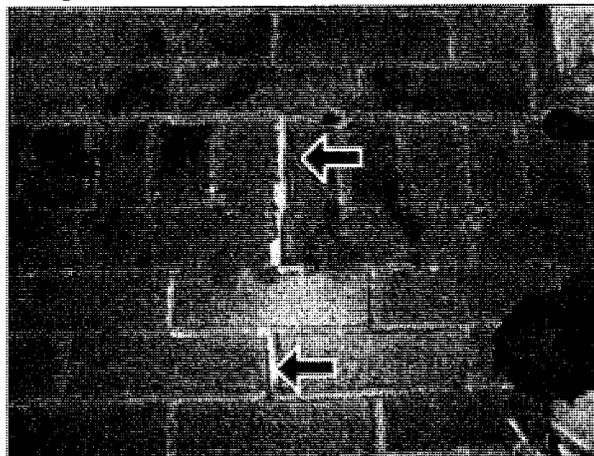
8.6 Picture 1

8.6 Brick hearth for fireplace at the Living room is missing grout. I recommend repair or replace as needed.
