## PUBLIC NOTICE

City of Highland Park  
Historic Preservation Commission  
**Thursday, June 12, 2014**  
1707 St. Johns Avenue, City Hall  
**7:30 p.m.**

### **REGULAR MEETING AGENDA**

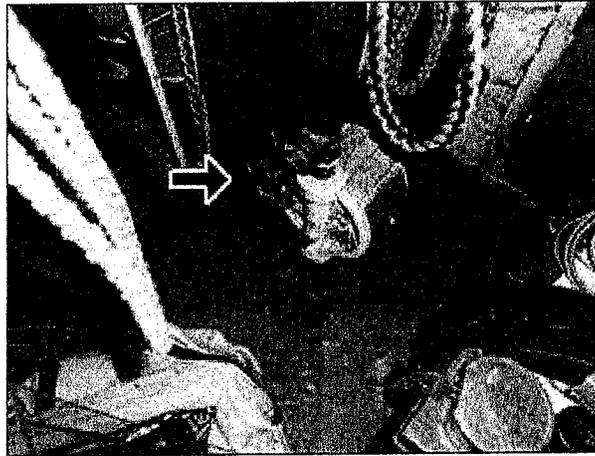
6.3 Picture 1

6.3 The main shut off is the red knob located at the furnace room. This is for your information.

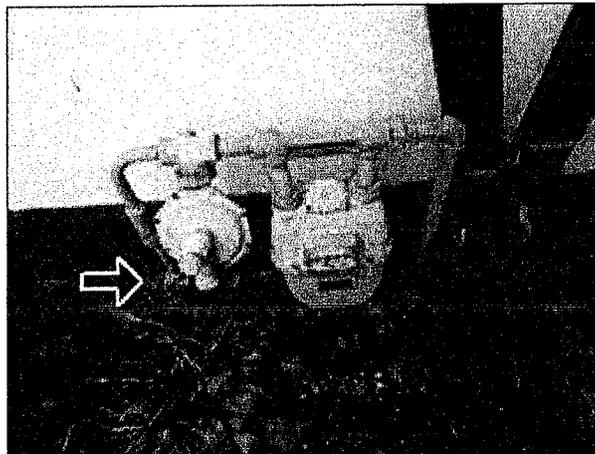
6.5 Picture 1

6.5 The main fuel shut off is at gas meter outside on the east side of the home.

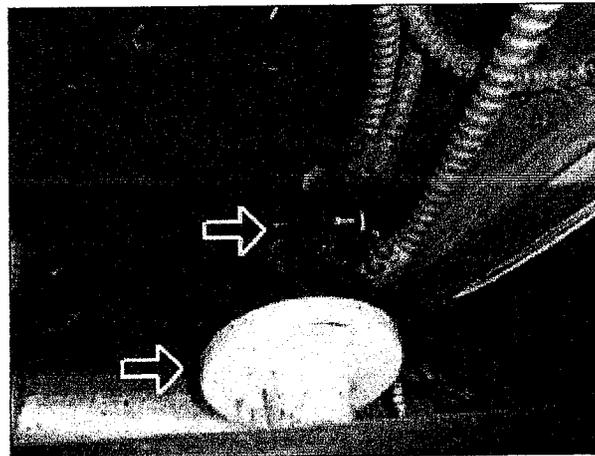
7.3 Picture 9

(7) The light fixture hangs by its own cord and should not at the Washer/Dryer room. This is a safety issue that needs to be corrected. A qualified licensed electrical contractor should correct as needed.

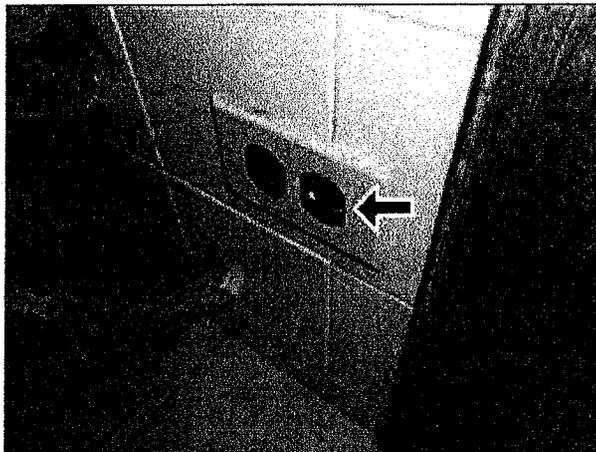
7.4 Picture 1

7.4 At least one "three-prong" outlet is outdated and not a three-prong GFCI (Ground Fault Circuit Interrupt) in the master bath. This is a safety issue that needs to be corrected. A qualified licensed electrical contractor should correct as needed.

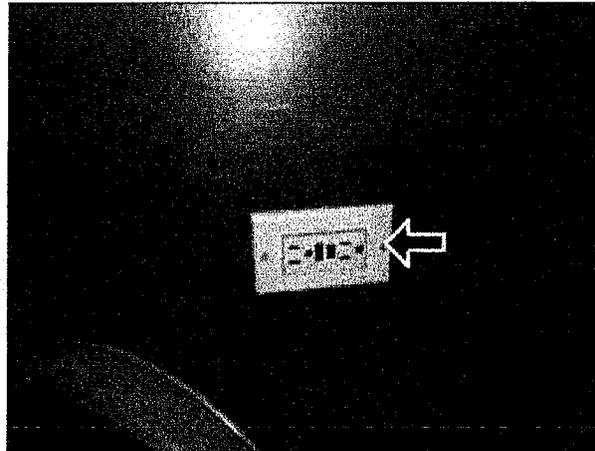
7.5 Picture 3

7.5 (1) At least One GFCI (Ground Fault Circuit Interrupter) outlet at the rear of home did not work or there is no power to outlet. This is a safety issue that needs to be corrected. A qualified licensed electrical contractor should correct as needed.

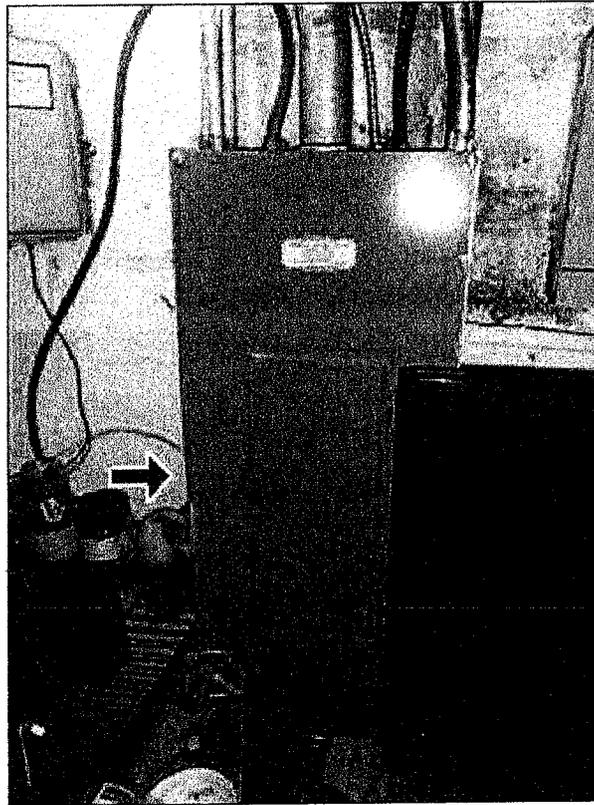
7.6 Picture 1

7.6 The main panel box is located at the basement.

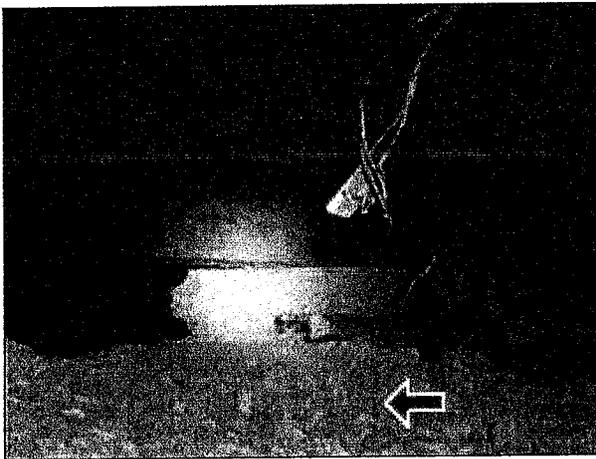
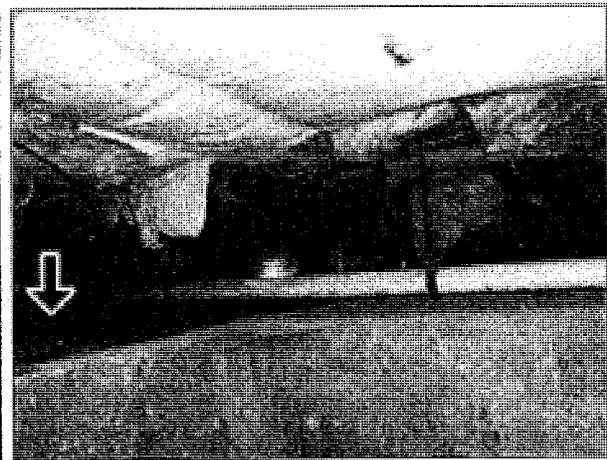
9.2 The vapor barrier (plastic) on the crawlspace ground is missing. A vapor barrier provides added protection to the floor system from moisture or dampness that can enter from ground. A qualified contractor should inspect and repair as needed.

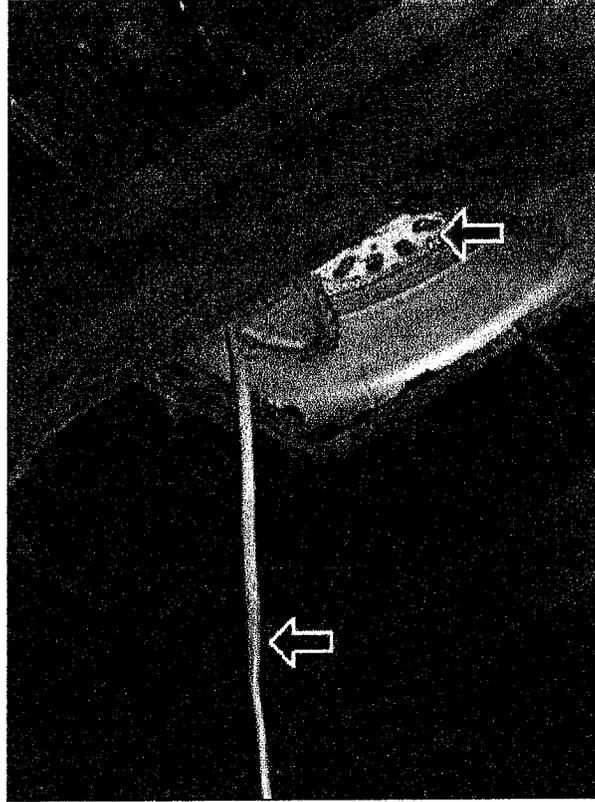
9.5 Picture 1

9.5 Thermostatically controlled vent fan in the attic is non operational and has romex wiring. Further inspection is needed by a qualified licensed electrical contractor. A qualified contractor should inspect and repair as needed.

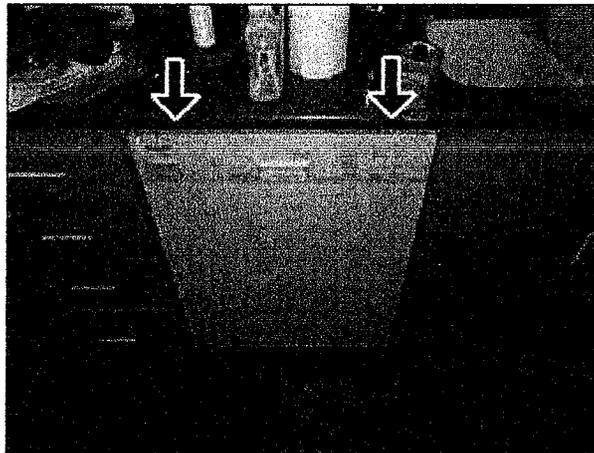
10.0 Picture 1

**10.0** The dishwasher is loose and needs securing to underside of countertop (using a proper length screw). I recommend repair as necessary.

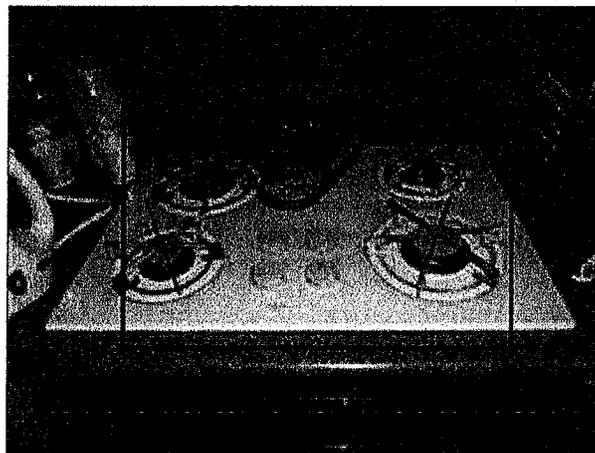
10.1 Picture 1

**10.1** The cooktop ignitors (on cook top) did not work when tested. I recommend repair as needed.
