City of Highland Park
Historic Preservation Commission
Thursday, October 13, 2016
1707 St. Johns Avenue, City Hall
7:30 p.m.

REGULAR MEETING AGENDA

To: Andy Cross, Senior Planner
From: Emmanuel Gomez, City Engineer
Date: 09/16/2016
Re **Highland Park Historic Preservation Commission
Central Ave Bridge Replacement**

DRAFT
SECTION 106 / SECTION 4(f)
DOCUMENTATION OF ADVERSE EFFECT

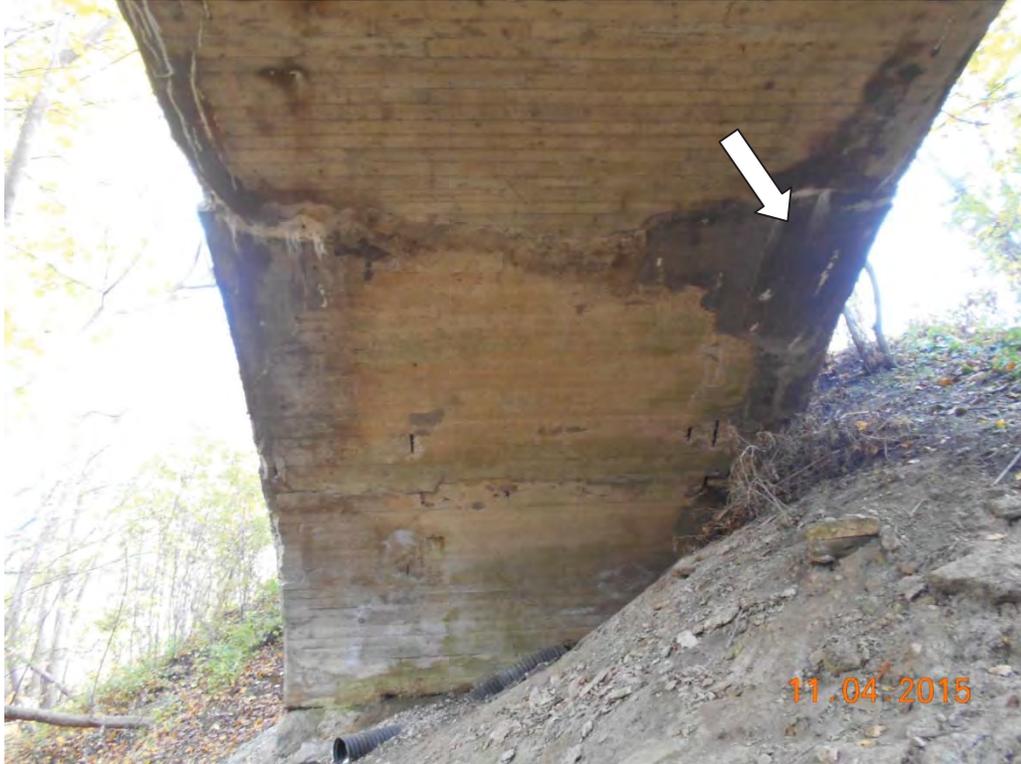
Photo 5: Underside of the arch looking west.

The arch exhibits severe deterioration. There are areas of spalling and delamination at the underside of the arch as well as the spandrel walls (Photos 5, 6, 8, 9). The spalled areas at the underside of the arch expose the primary reinforcing steel which show section loss. At the center of the arch on the north and south end of the underside of the arch ring, there are concentrated areas of efflorescence and the concrete is deteriorating (Photo 7). The efflorescence indicates that the wearing surface has failed and water is penetrating through the fill and into the concrete. The areas that have been patched when the bridge was rehabilitated in 2008 are also delaminated and spalled with efflorescence (Photo 5, 6).

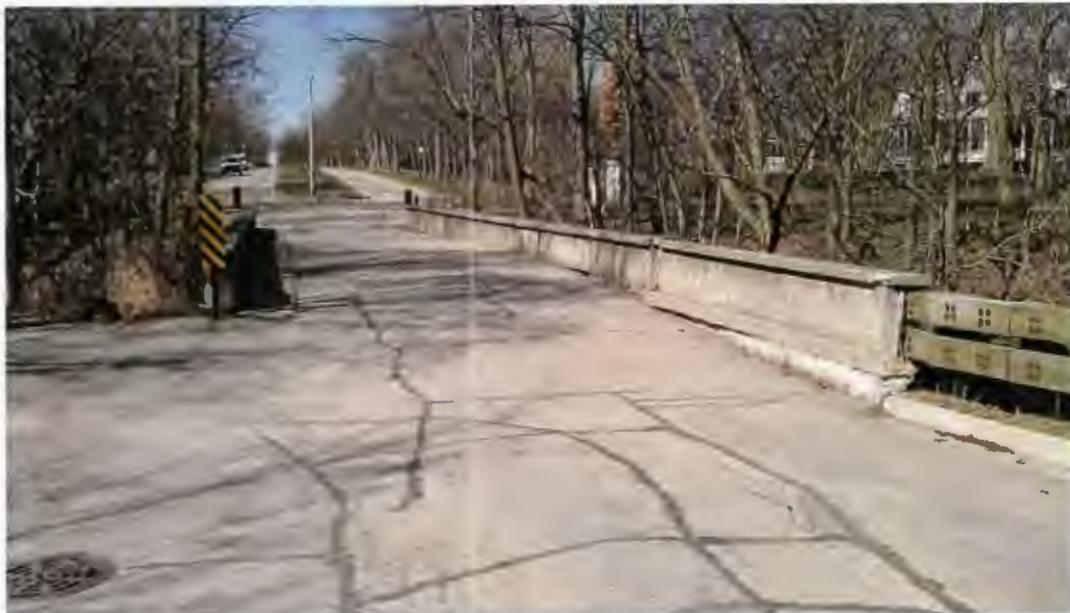
Image Ctrl 01b - Central Av Bridge East Approach, April 2014

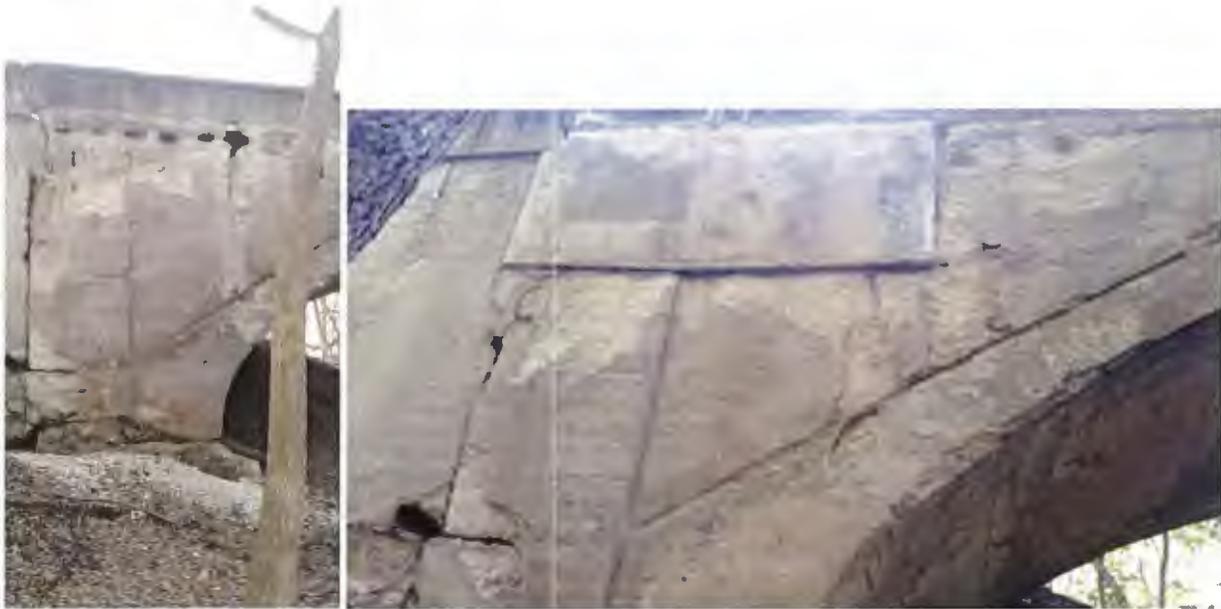
Ctrl 02a, NE Spandrel - before 09/09/2014

Ctrl 02b, NE Spandrel - after 09/14/2014

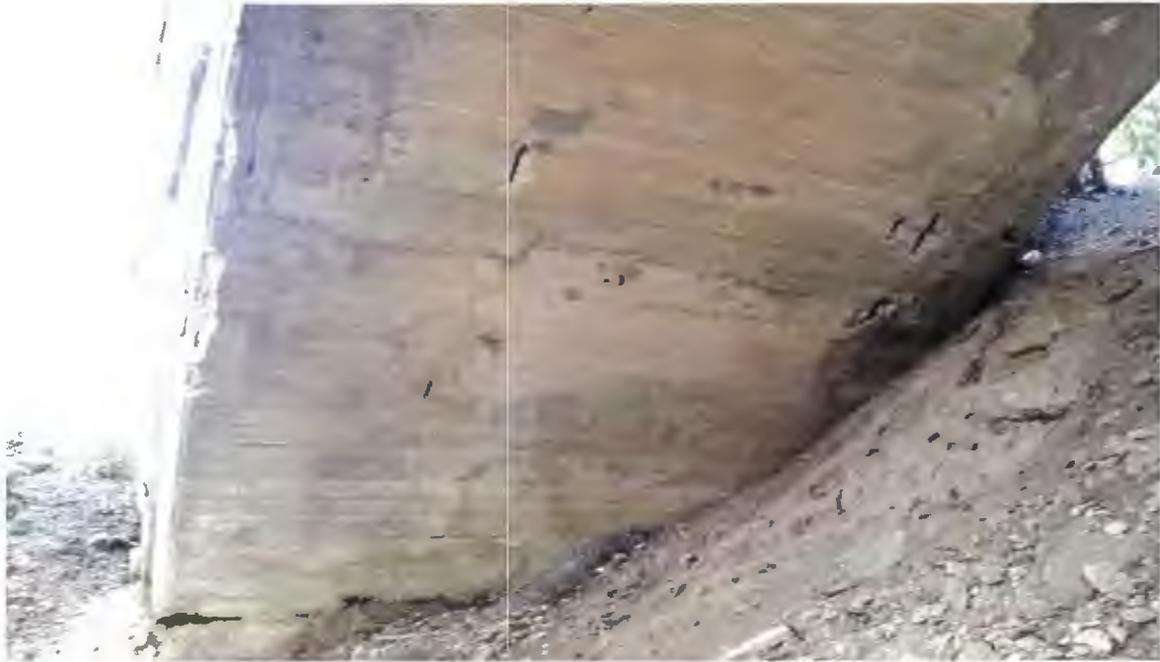
Photo Ctrl 05- Central Av Bridge, East Arch Foundation Elevations, 08/19/2014

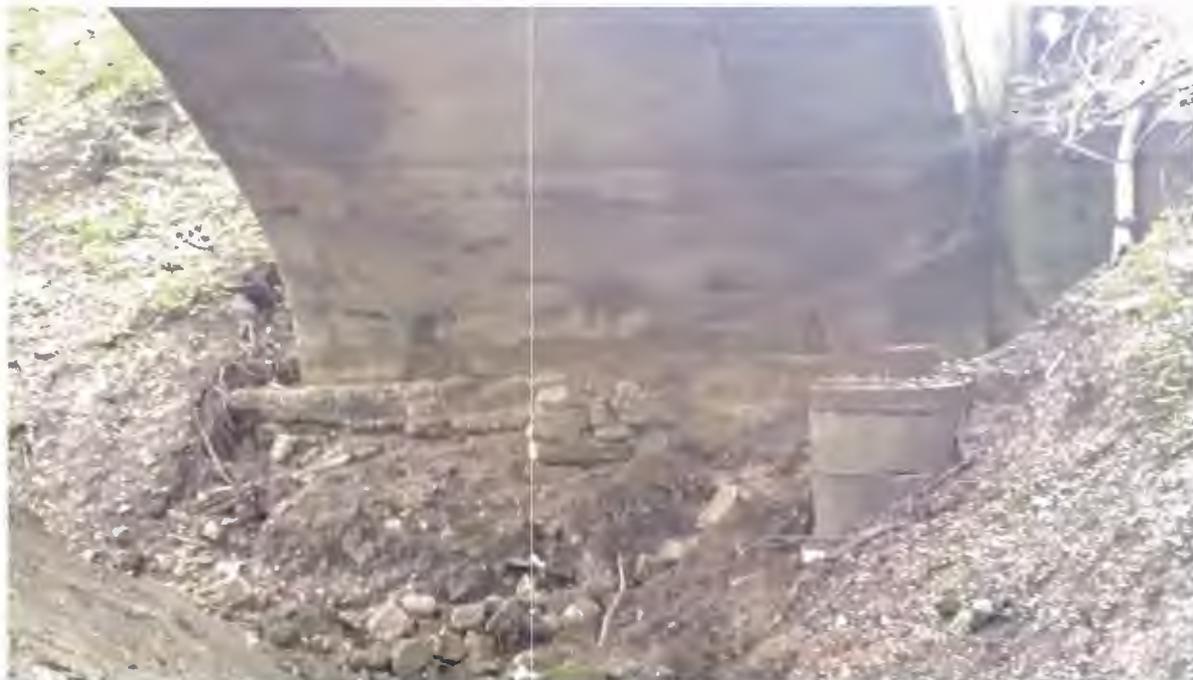
Photo Ctrl 06 – Central Av Bridge – West Arch Foundation Elevations, 08/19/2014

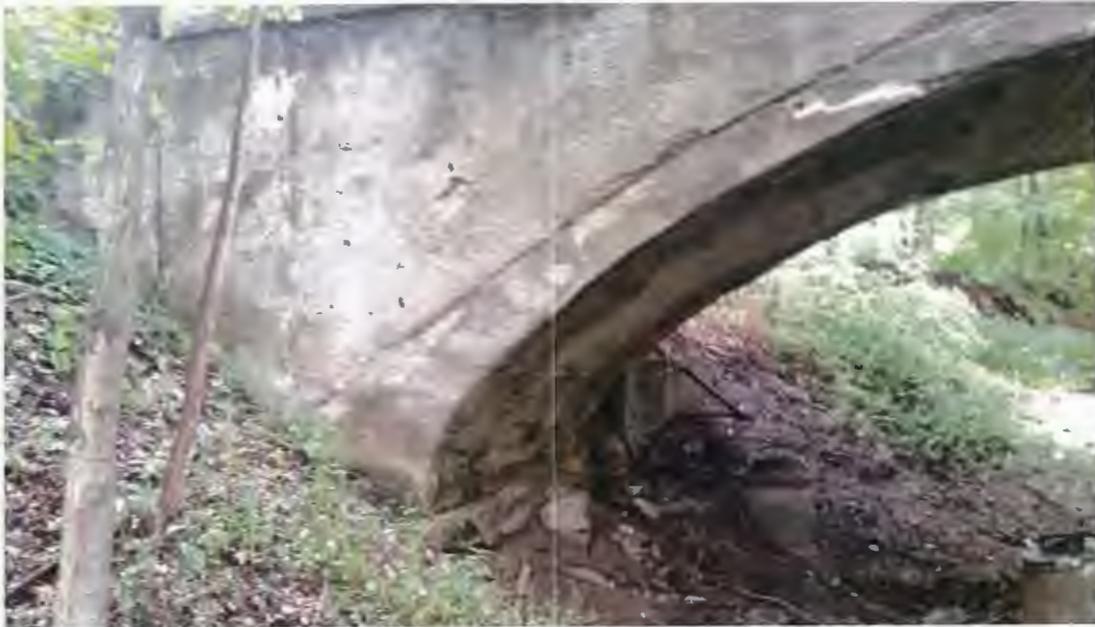
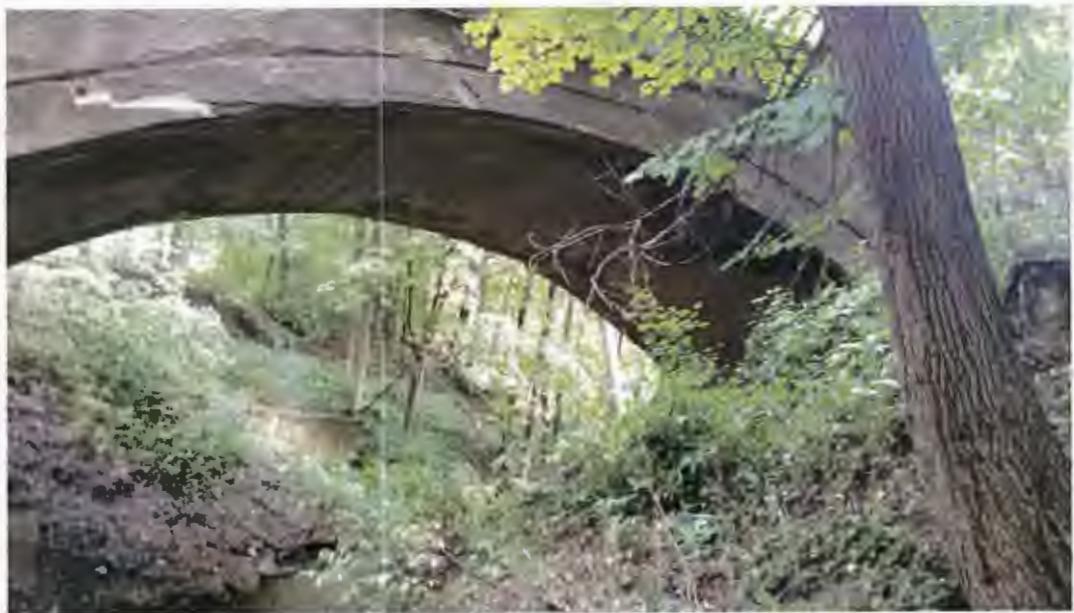
Photo Ctrl 09a-09b – Central Av Bridge, Midspan arch conditions South Elevations, 08/19/2014

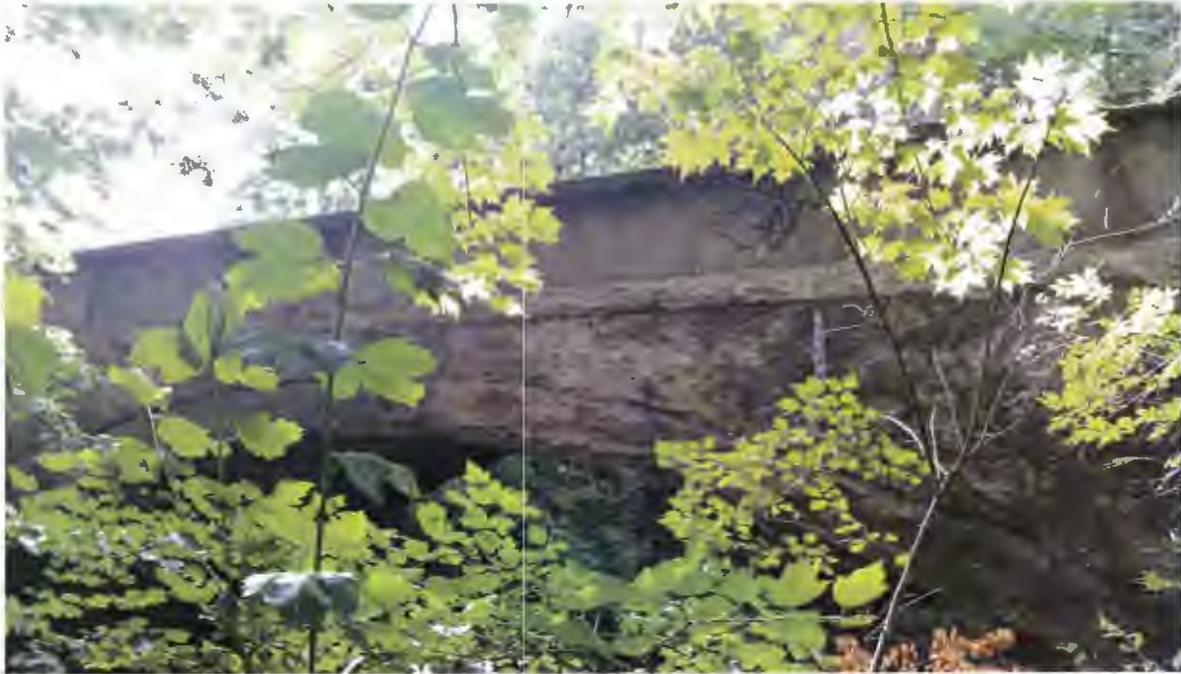
Photo Ctrl 10 – Central Av Bridge, Midspan spandrel conditions North Elevations, 08/19/2014
